**"Achieving 100% GT's Start-up Reliability in  
Genelba's CCGT plant"  
- A case study-**

**Petrobras Energía S.A.  
Central Termoeléctrica Genelba**

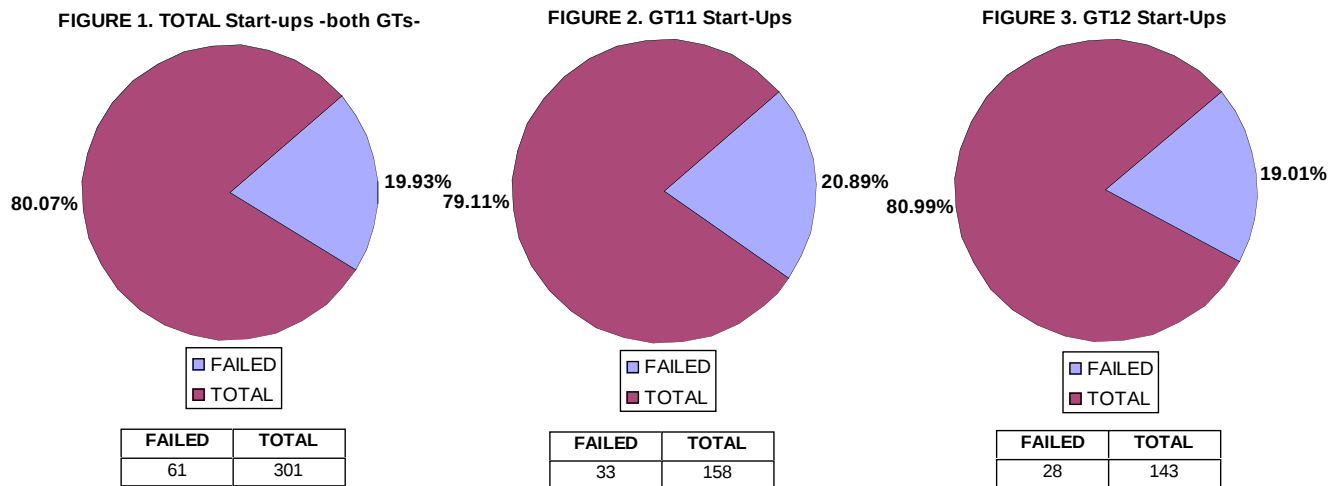
4.a- Firstly, the total rates of Failed Start-ups, as illustrated in Figure 1, and then the particular ones of GT11 and GT12, as shown in Figure 2 and 3, were analyzed. It was observed that both turbines behaved similarly so the idea that a specific problem could be directly associated with one of the GTs was ruled out.

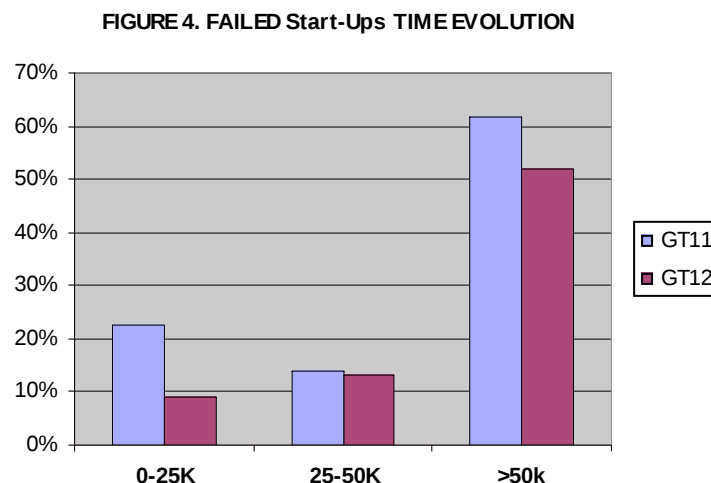
4. b- Secondly, the problem development over time was analysed. For this purpose, it was not relevant to consider calendar years as time intervals but periods representing the machine life cycle. Then the GT's major inspections corresponding to 25000 and 50000 operation hours were used as milestone to determine relevant time periods. Figure 4 illustrates the failure development over time for GT11 and GT12.

Figure 4 shows an increase in the rate percentage of the GT Failed Start-ups after 50000 EOH Major Inspection. This degradation can be seen in both gas turbines. However, there are a few start-ups during this period and precisely the last failed start-ups were the ones which motivated this study. Thus the proportional increase in failures in this last period was not considered relevant.

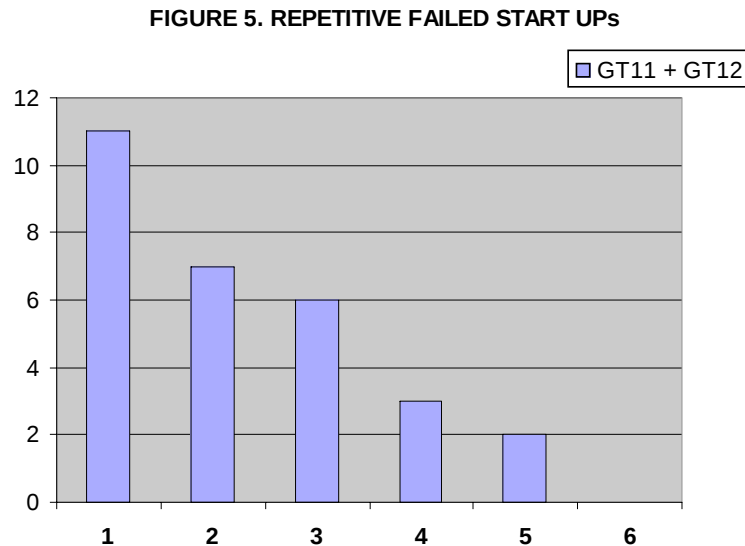
4. c- Other important aspects to study were the successive repetitive events of GT Failed Start-ups. Figure 5 illustrates a frequency diagram whose x-axis represents the number of failed Start-ups successive repetitions while y-axis shows the amount of events in which the repetitions occurred. Note that only 11 out of 61 historical Failed Start-ups did not have failure successive repetition. The other 50 Failed Start-ups ( $2 \times 7 + 3 \times 6 + 4 \times 2 + 5 \times 2$ ) were repetitions. That is, there were 17 independent Failed Start-up events ( $7 + 6 + 2 + 2$ ) in which at least one additional repetition to achieve a successful start-up was necessary.

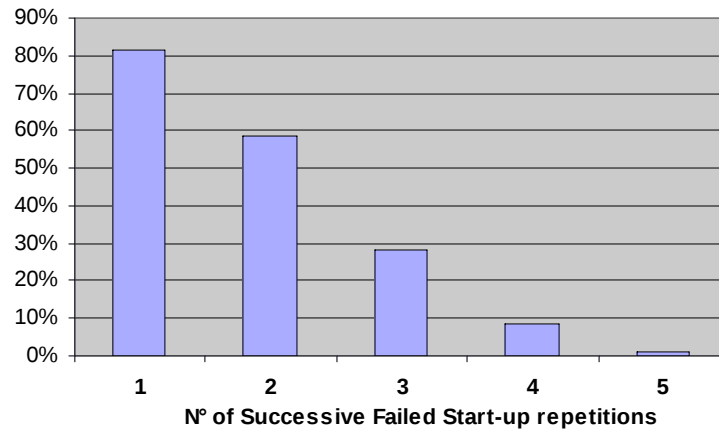
**FIGURE 6. Probability of Failure when a failed start-up has just occurred.**

its immediate successive repetitions. Figure 6 shows Bayes's probability for the occurrence of a Failed Start-up when a Failed Start-up has just occurred. We can see that this probability exceeds 80%. The failure probability of any start-up was 20% according to Figures 1, 2 and 3. But once a start-up fails, the failure probability increases to 80% and decreases again below 20% only after 3 attempts, as illustrated in Figure 6. Based on this information, the team concluded that most of the time Failed Start-ups required several start-ups to succeed and that these successive events should not be considered independent. These conclusions helped the team to narrow down the scope of possible root causes for the problem.

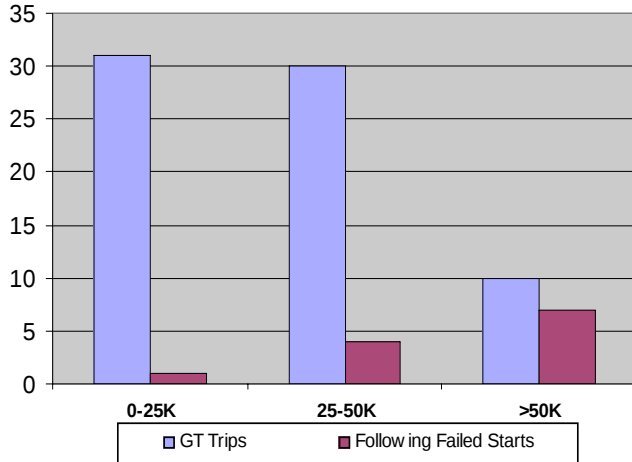
**FIGURE 7. Failed Start-Ups after GT Trip**

4.d- Another approach applied studied the relationship between Failed Start-ups and the start-ups after a GT trip and also with the start-ups occurring after a GT had been shutdown for some days (>2 days) as illustrated in Figures 7 and 8. Relevant patterns of behaviour were not observed. There were a few Failed Start-ups not only after trips but also after prolonged shutdowns.

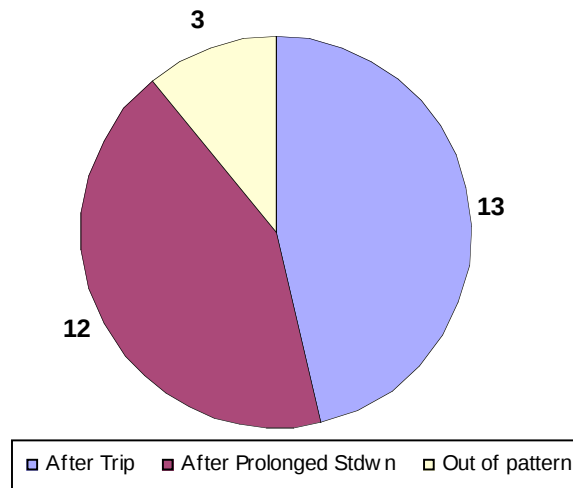
**FIGURE 9. Relationship among Failed Start-ups, Trips and Prolonged Shutdowns.**

4. e- With the results from 4.-d, the same study was carried out although this time inverting the relationship. That is, answer the question: taking into account all the independent events of Failed Start-ups, how many occurred after GT trips? How many occurred after long shutdowns? Figure 9 shows this relationship. The results were relevant. Except 3 start-ups out of pattern, the rest of the Failed Start-ups occurred after a turbine trip (13) or after a prolonged shutdown (12). It is worth mentioning that the 27 failed start-ups in Figure 9 are independent Failed Start-ups according to the conclusions in Figure 6. These 27 independent Failed Start-ups, with its successive repetitions, generated the 61 Failed Start-ups of the history as indicated in Figures 1, 2 and 3.

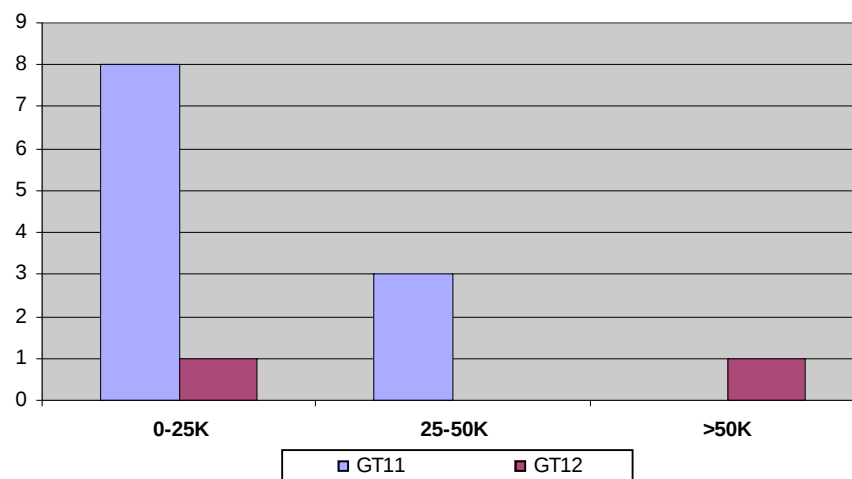
**FIGURE 10. Failed Start-Ups with EOH accumulation.**

4. f- In the last statistical analysis, the team studied which of the 61 Failed Start-ups caused an accumulation of EOH according to what is mentioned in 2 above. Figure 10 shows this information.

13 out of 61 total Failed Start-ups reached the Flame-On condition and then the flame blew out. After a detailed analysis of the 13 cases, the team concluded that all of them occurred after a prolonged GT shutdown.

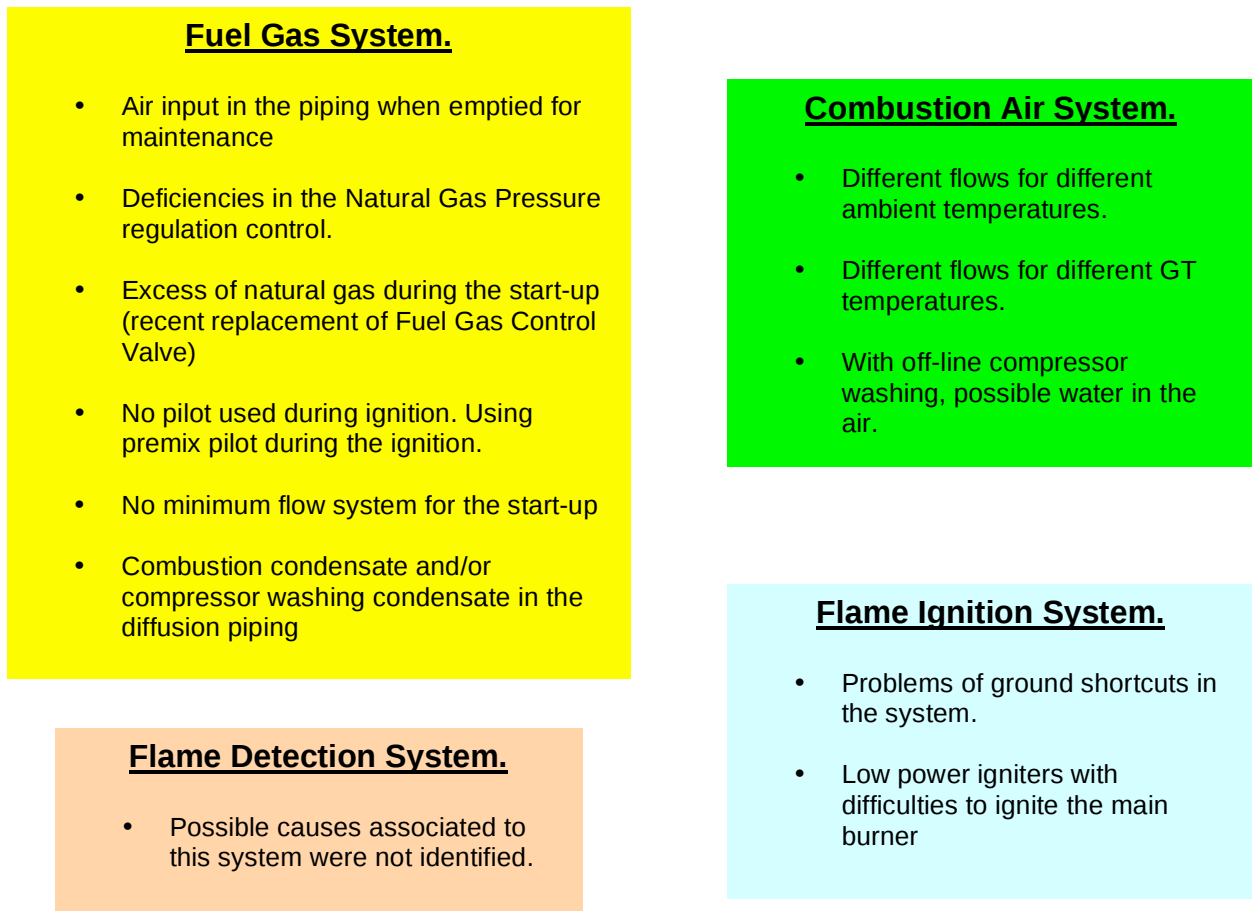
**FIGURE 11. Failed Start-Ups Affinity Diagram.**

By means of the Affinity Diagram, the team applied the brainstorming technique, classifying the ideas in these four natural groups. Figure 11 illustrates the resulting Affinity Diagram.

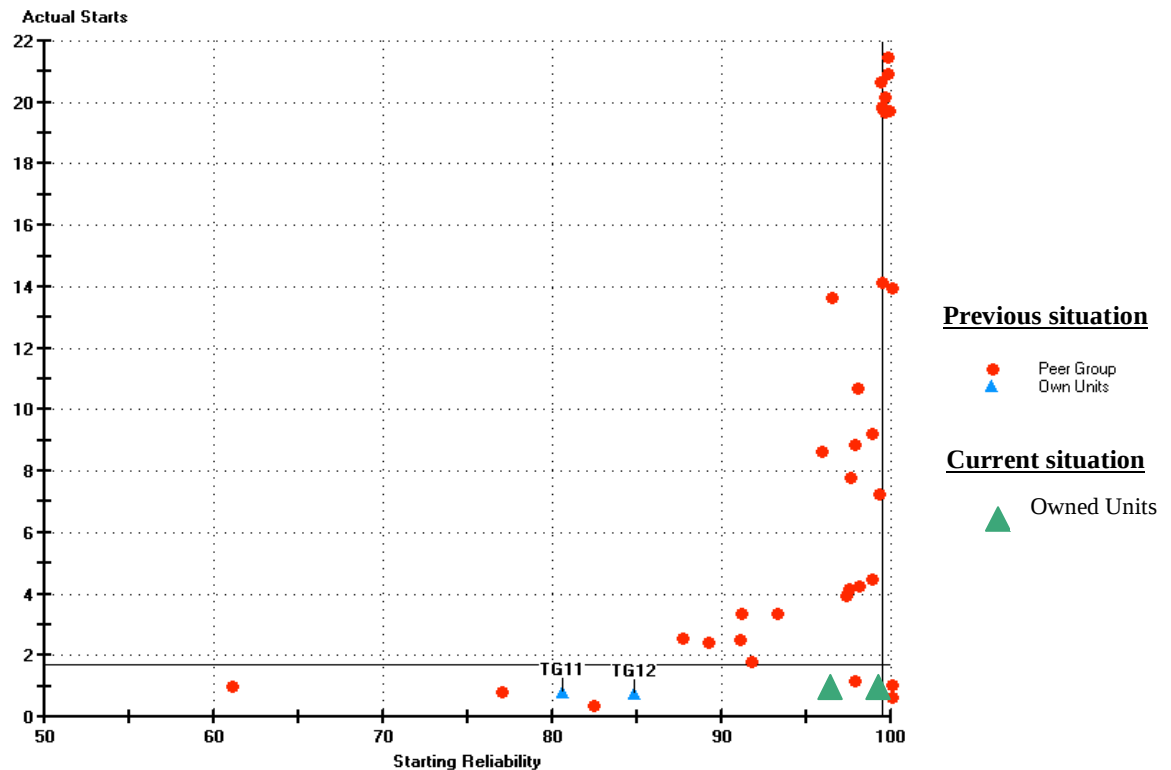
**FIGURE 12. Benchmarking position, before and after the case study**

The results of a benchmarking programme developed by NCI and in which Genelba participates are illustrated in Figure 12. It shows the reliability comparative data of the start-up process. Note Genelba’s situation compared with other similar power plants before and after the study described in this paper.
