# FAILURES BY SCC IN BURIED PIPELINES

C. Manfredi<sup>a</sup>, J.L. Otegui<sup>a</sup>, J. Motylicki<sup>b</sup>, A. Trunzo<sup>c</sup> and D. Falabella<sup>d</sup>

<sup>a</sup> INTEMA, Universidad Nacional de Mar del Plata

Until a few years ago there had been no record of Stress Corrosion Cracking (SCC) as a main cause of failures in Argentine pipelines, but as the pipeline system became of a certain age this mechanism started to have an important impact on reliability.. This study analyzes the causes of three blowouts attributed to high pH SCC in different oil and natural gas transmission pipelines, which occurred by the sudden propagation of longitudinal cracks at the outer surface of the pipes.

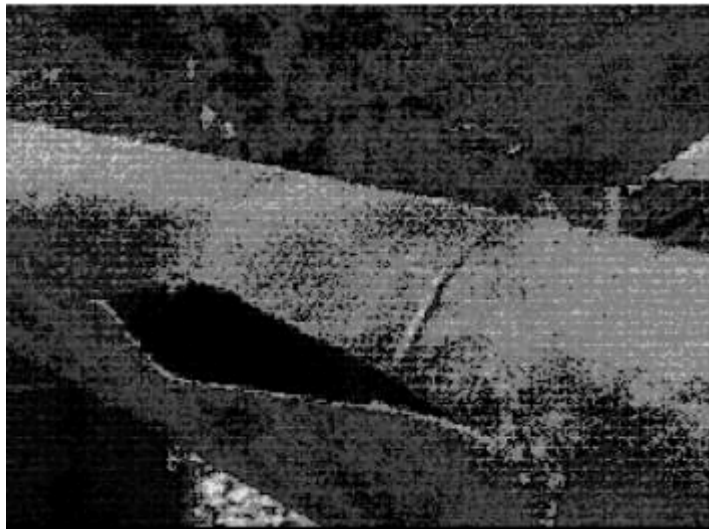
**Figure 1** shows the visual aspect of this failure. The blowout occurred near the pump station, by the sudden propagation of a longitudinal crack along the longitudinal ERW weld material. Total length of the fracture was 720 mm and involved two pipes, running through the circumferencial weld. Pipe coating was lost during the blowout and following fire. No metal loss due to corrosion was observed. A careful observation of the fracture surface using a low magnification stereo microscope allowed to identify two kinds of propagation: At the extremes of the failure, propagation is characteristic of mode 1, driven by the tensile hoop stress, with chevron marks pointed to the center. In the center, irregular stepped propagation is observed, with clear evidence of coalescence of longitudinally oriented parallel defects. **Figure 2** shows this type of propagation. Low magnification fractographic observations show a thin black film covering the parallel initial defects.

**Figure 1** visual aspect of the failure in the oil pipeline

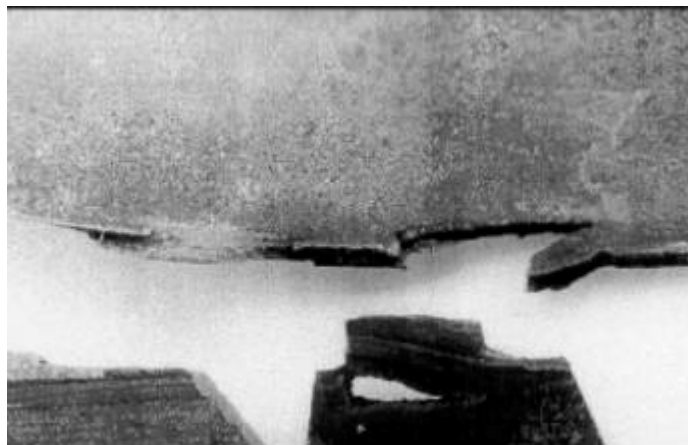
**Figure 2** Irregular propagation at the origin of failure in the oil pipeline

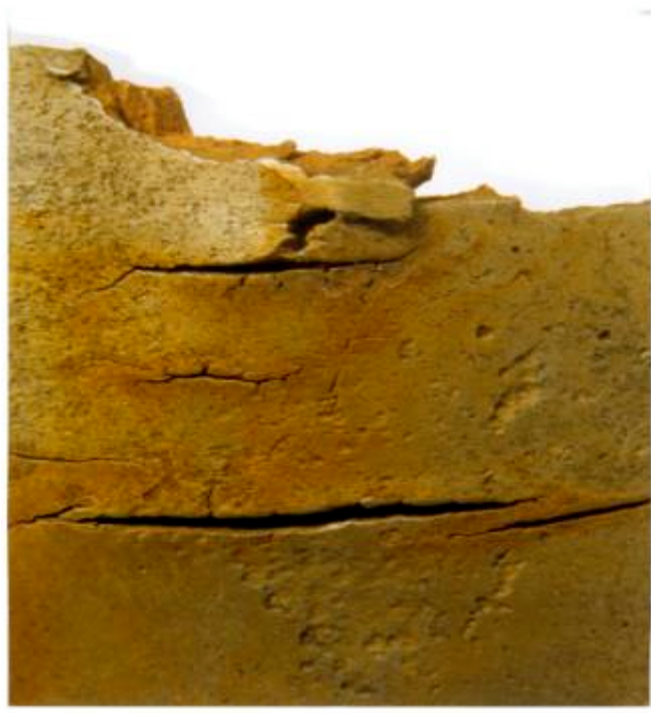
longitudinal weld are is of the type double submerged arc welding (DSAW). The pipe is coated with coal tar and was 28 years old at the moment of the failure. Design maximum allowable operating pressure (MAOP) is 61.3 Kg/cm<sup>2</sup>. At the moment of the failure, the operating pressure was 61.2 Kg/cm<sup>2</sup>. Corrosion protection is obtained by coating and impressed current cathodic protection. The main fracture occurred in base material, was parallel to the longitudinal axis of the pipe, and shows two fracture origins separated by 6 meters. Total length of the fracture is 31 meters. A relatively large number of secondary cracks in the vicinity of the fracture origin were found by visual inspection. **Figure 3** shows the aspect of some of these secondary cracks, close to the main fracture path.

secondary cracks close to the main fracture in the gas pipeline failed near a compressor station.

Fractographic observations on optical and scanning electron microscopes show that the fracture surface has cracks initiating on the external surface. The cracks penetrated the wall of the pipe to a maximum depth of about 3.8 mm. The remaining portion of the fracture was caused by mechanical tearing of the ligament, when the small remaining section of the wall pipe could no longer support the internal gas pressure. No surface corrosion was observed and a black film is partially covering the fracture surface. Wet fluorescent magnetic particle inspection detected small surface flaws in the form of isolated cracks and crack colonies. The locations of the colonies were intermittent around the central portion of the fracture, the longest crack colony measured approximately 90 mm in length (combination of five cracks end-to-end)

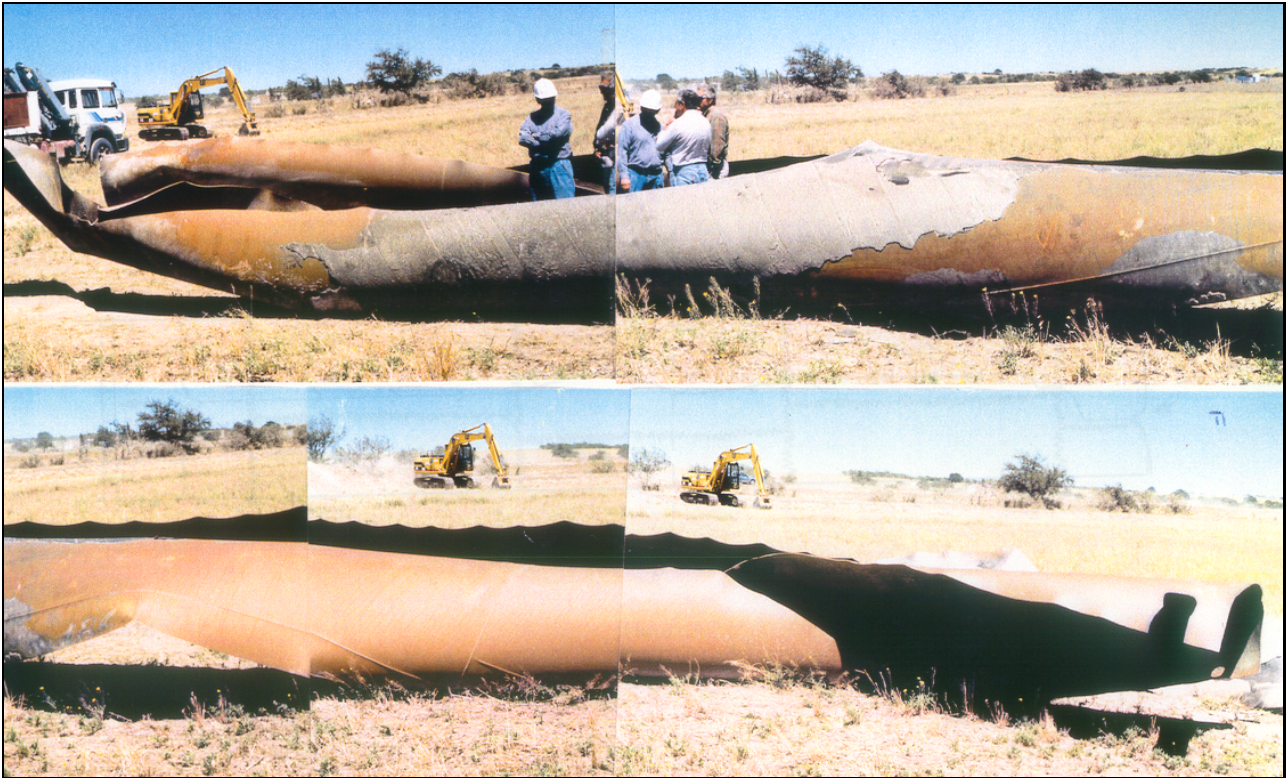
**Figure 4:**

**Figure 4** shows general characteristics of the failed portion of the pipe. The primary fracture is parallel to the longitudinal axis of the pipe. Total length of the fracture was 38 meters. A relatively large number of secondary cracks in the vicinity of the fracture origin were found by magnetic particle inspection, some of them are shown in **Figure 5**. **Figure 6** shows a low magnification fractographic section of the failure origin. Again a thin black film was found covering the parallel initial defects. **Figure 7** shows the same portion of the pipe when observed in the SEM at higher magnification. A

Failure in a natural gas pipeline, 23 kilometers downstream from the closest compressor station.

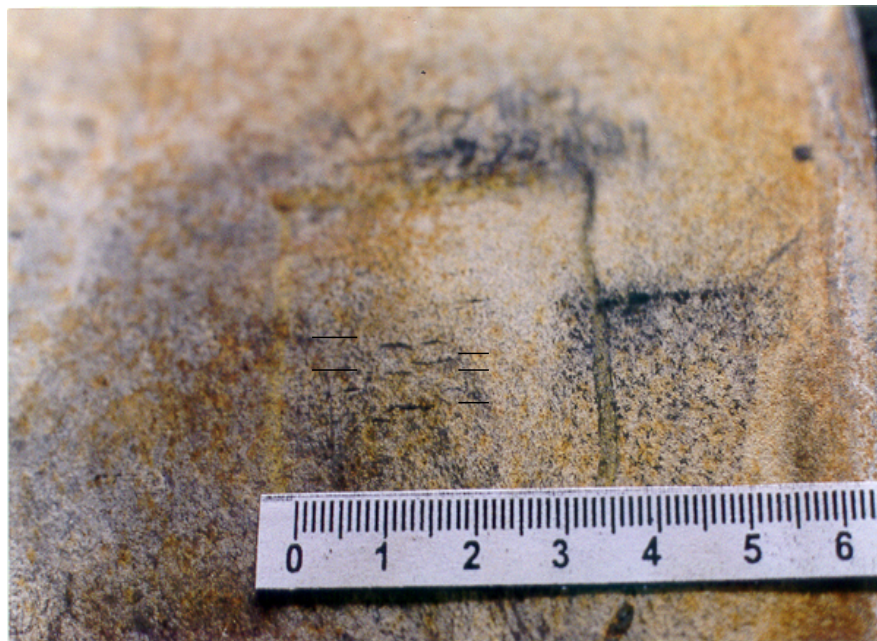
**Figure 5:** secondary cracks found by magnetic particle inspection

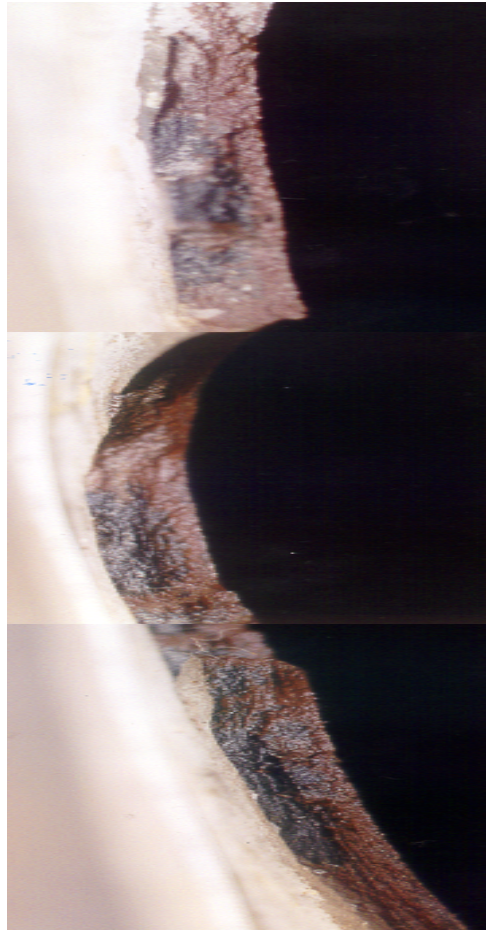
**Figure 6** fractographic section of the failure origin showing the black films

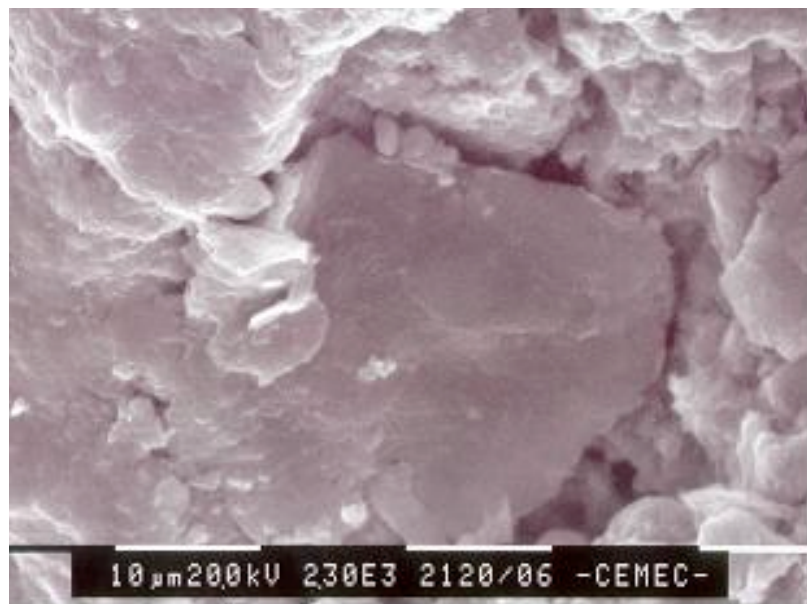
clear intergranular crack path can be seen. Disbonded coating was found in a nearby region downstream of the failure site. The pH of the electrolyte trapped in the gap beneath the disbonded coating was measured using Litmus paper. Values of pH ranged between 8 and 9.

**Figure 7:** SEM micrograph showing an intergranular crack path

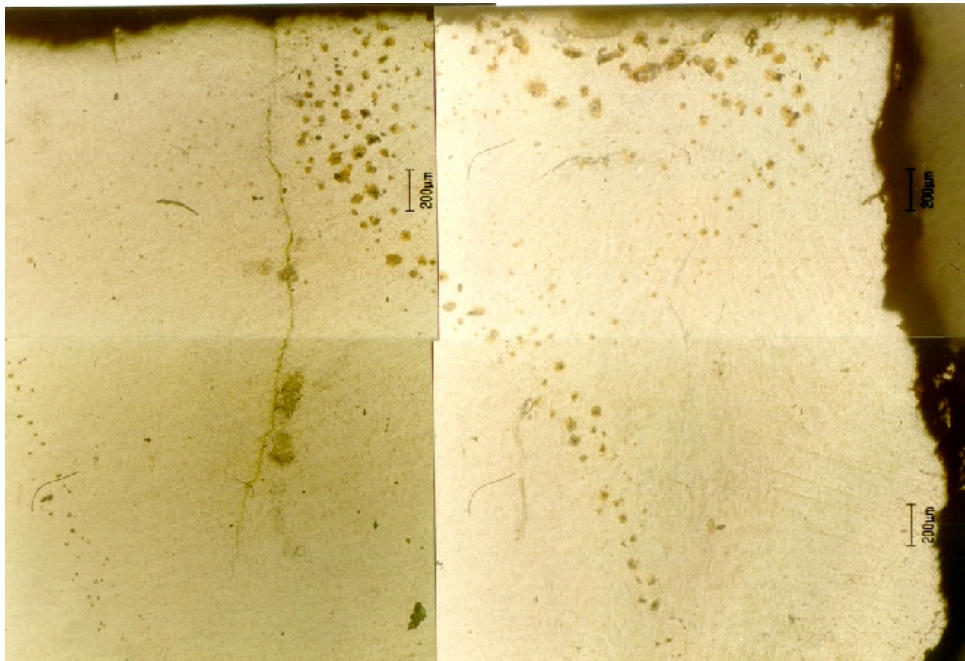
Metallographic specimens from each of the failures were prepared for microstructural examination. **Figure 8** shows typical microstructures of base metal (left), and weld metal (center and right) for the oil ERW pipe. The external pipe surface runs horizontal in the upper part of the photograph, and the main crack runs vertical on the right side. Note the severe microstructural banding of base metal, running parallel to the pipe surfaces. This banding is typical of pipes, and is due to the lamination process during the fabrication of the tube from plate material. A large number of inclusions are present in the material, which are also aligned. Some of these inclusions are very long and shallow. Elongated type II MnS and planar arrays of oxides or complex oxy-sulphite inclusions might act as preferential sites for initiation of surface cracks or propagation of preexisting defects. Note the secondary cracks close to the center line of the ERW seam weld. Also in this region are small defects of lack of fusion, with caught non metallic inclusions, located in the highly deformed weld area. They present plane or curved surfaces, with small protuberances in the ends. Maximum depths and lengths measured are less than 0.5 mm, while most defects are about 0.25 mm. Microstructural characteristics of the two gas pipelines also show the banded microstructure typical of API 5 L materials.

**Figure 8:** microstructures of base metal (left), and weld metal for the oil ERW pipe. Note banding, secondary SCC cracks and small defects of lack of fusion and inclusions

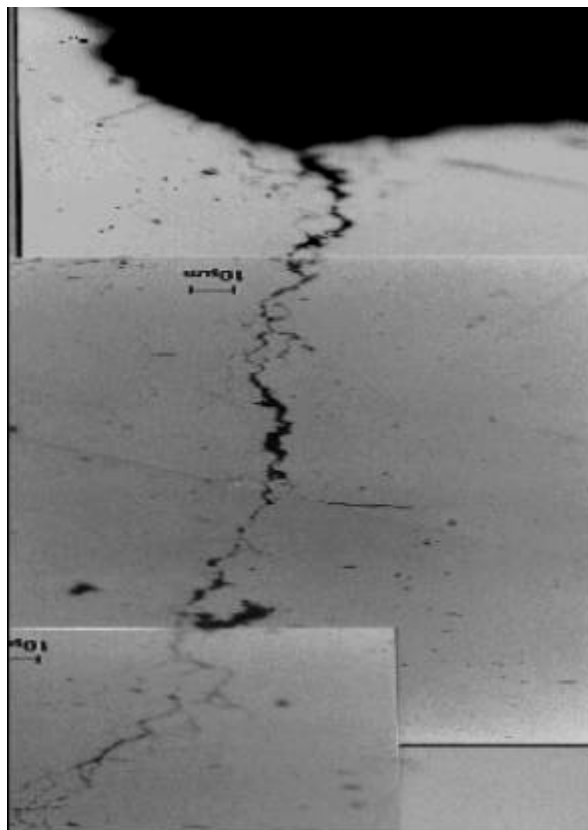
Metallographic samples of cross sections at the fracture origin were prepared to determine the nature of the cracking and to determine the morphology of the cracks. **Figure 9** shows the through wall aspect of one of the defects in base metal. It can be seen that the cracks are mainly intergranular and branched, initiating from the outer surface.

**Figure 9:** Typical through wall aspect of one of the cracks in base metal
