## **CASE HISTORY OF INTEGRITY MANAGEMENT ON A CORRODED PIPELINE**

TransCanada PipeLines

March 1999

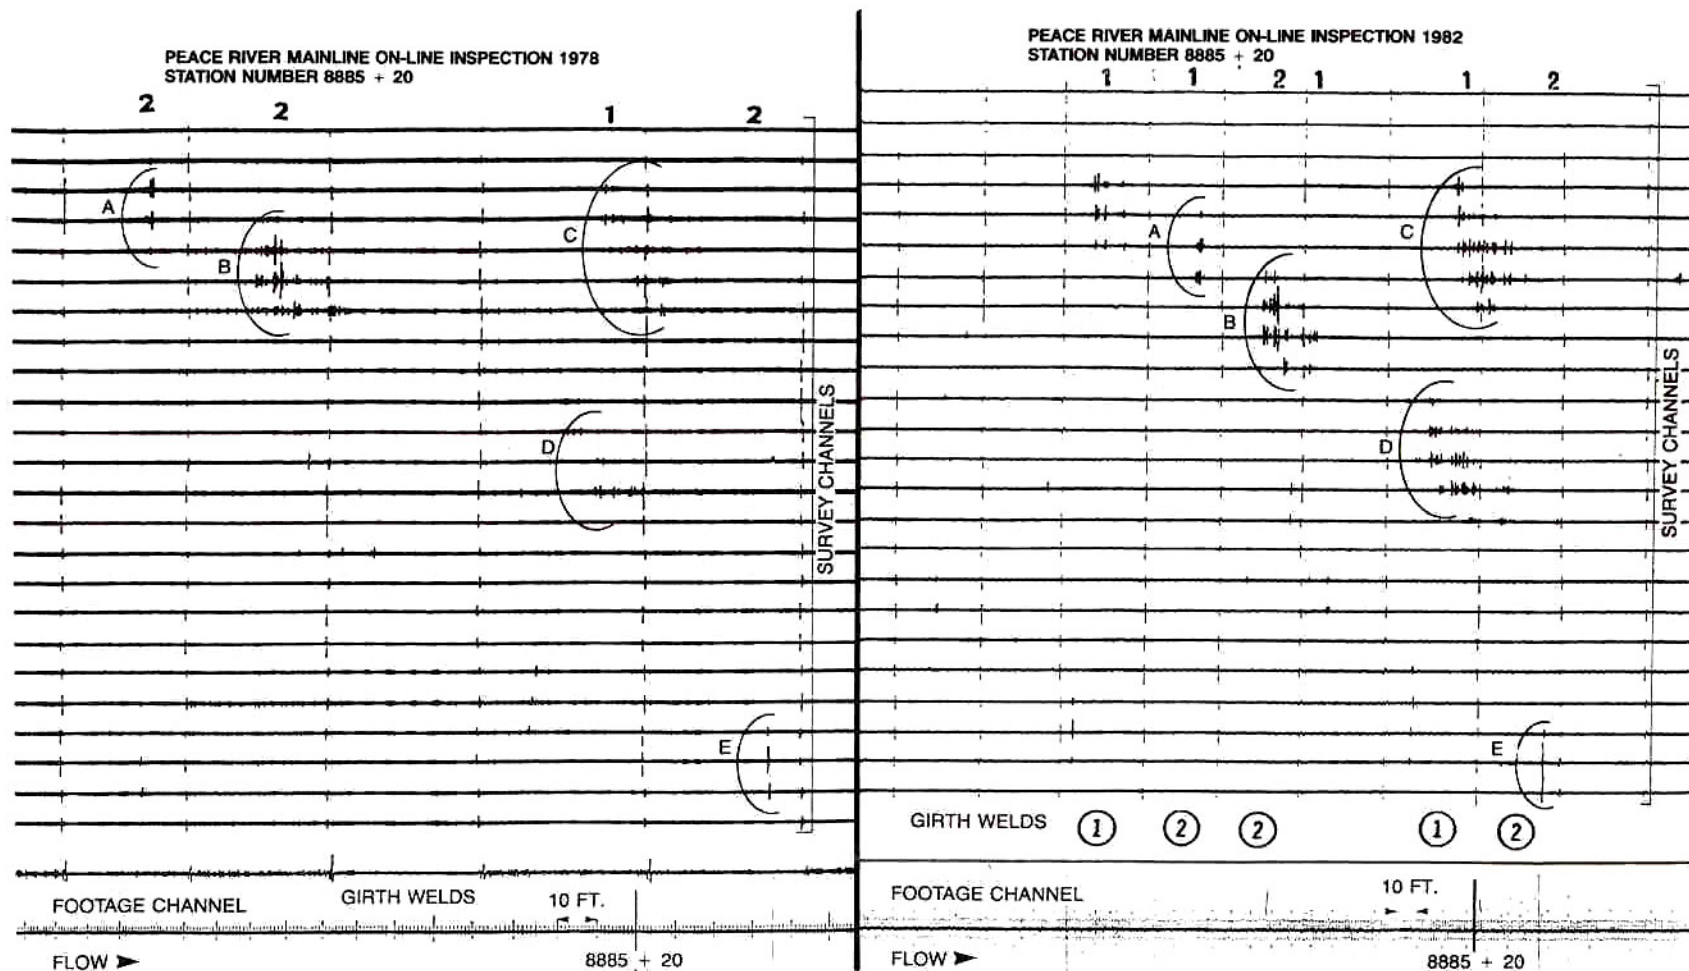
By 1981, the cathodic protection system was virtually 100% reliable and the 1000 mV criteria was achieved. A re-inspection of the line was performed and the data compared visually to previous inspections from 1975 and 1978. The comparison clearly showed that in spite of the improvements in the CP system, reliability and level of protection, corrosion was continuing to progress on the pipeline. Figure 1 shows the low resolution ILI trace for a typical location. On the left are records from 1978 and on the right are records from 1982. Note the changes in signal amplitude and extent at locations C and D while locations A and B show no change. Note also that upstream of A on the 1982 inspection there appears to be new corrosion.

Figure 1: Illustration of Low Resolution ILI Data, on the Left from 1978 and on the Right from 1982

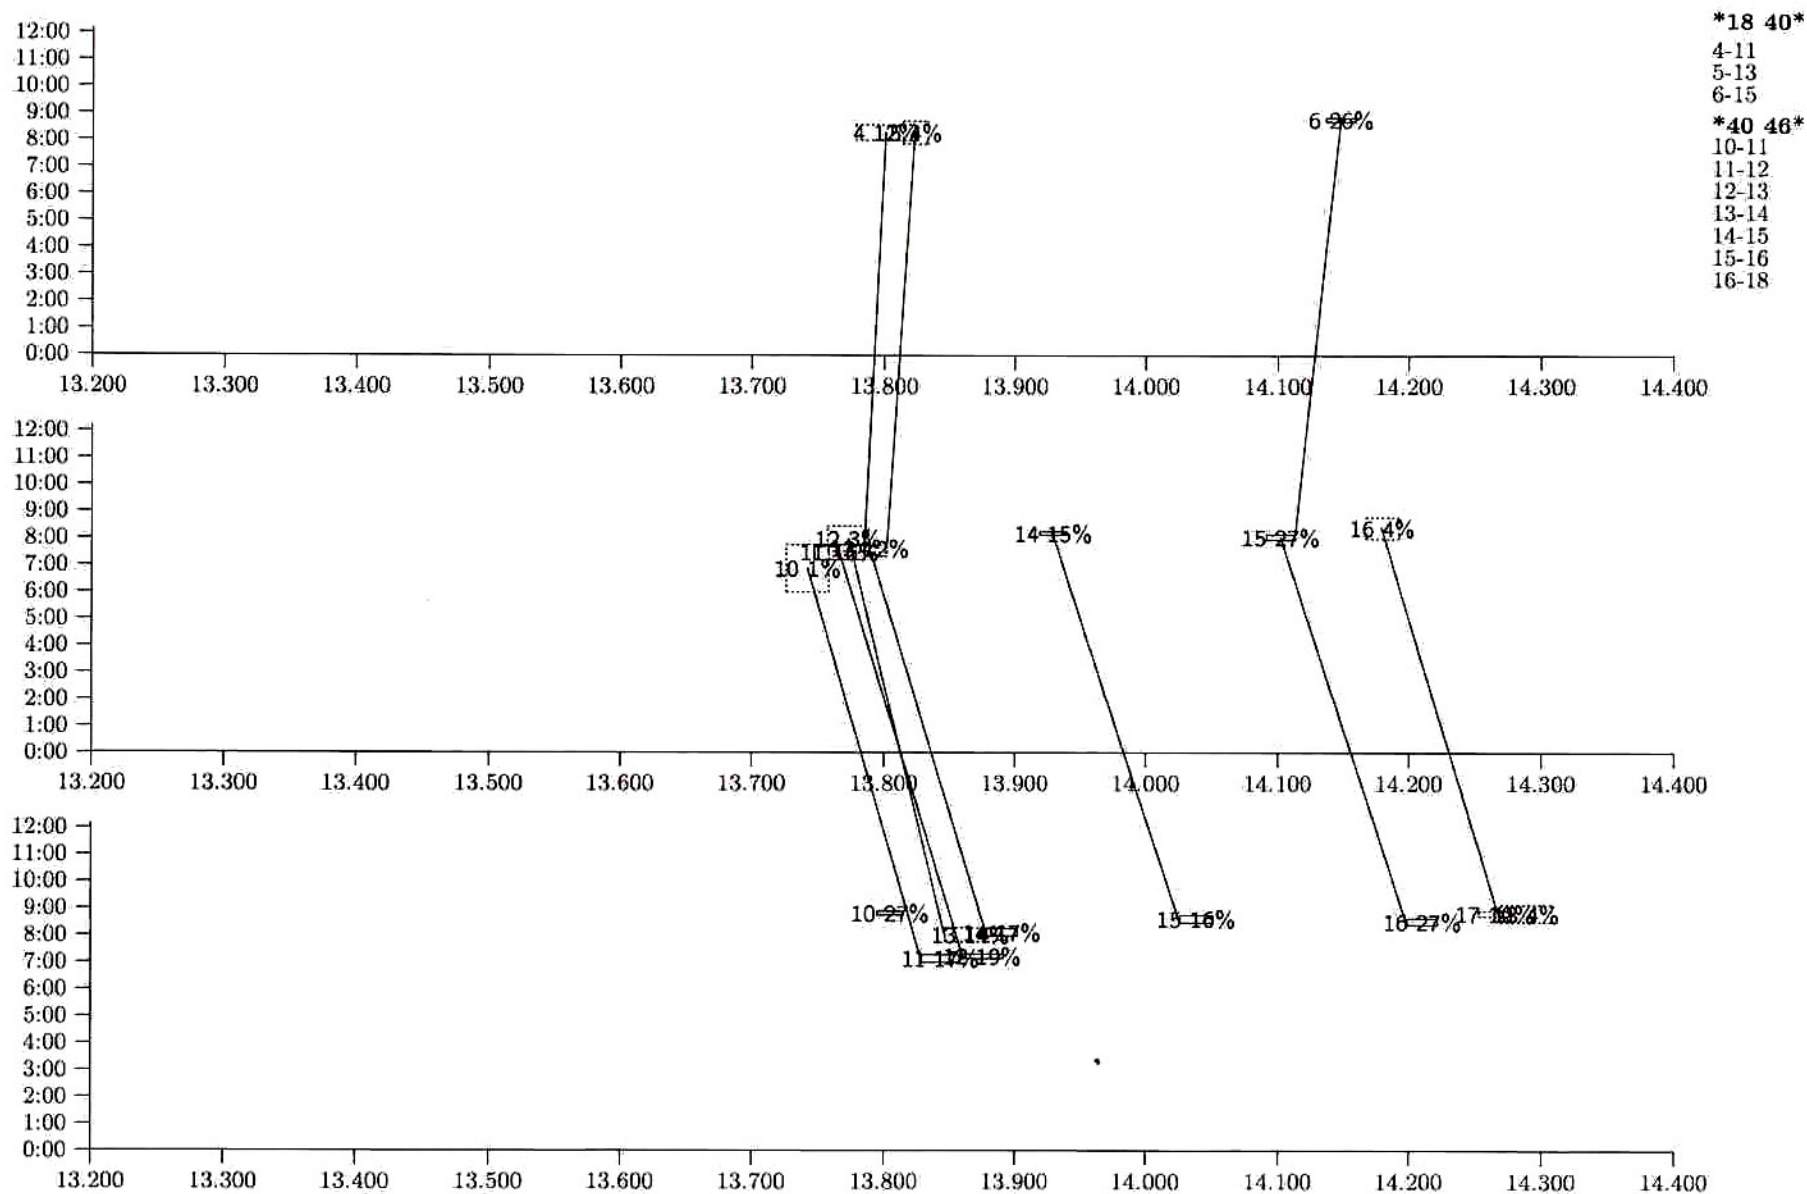
Matching from three inspections is illustrated in Figure 2. The horizontal axis is the odometer reading in a particular joint of pipe, and the vertical axis is the orientation of the features in hours. The top set of corrosion is from the 1986 inspection; the middle set of data is from 1990 and the bottom set is from 1994. The features are from the NPS 20 pipe. Note that the number of corrosion features on this one metre section of pipe has increased from 3 in 1986 to 9 in 1994. Each feature is assigned an index number, shown to the left of each box, and centred on the box is its depth in percentage of wall penetration. Dashed lines represent features less than 15% penetration for ease of checking the matches. The notation at the upper right hand corner is for debugging purposes and shows the matches by index number.

Figure 2: Example of Growth Using 1986, 1990 and 1994 ILI Data

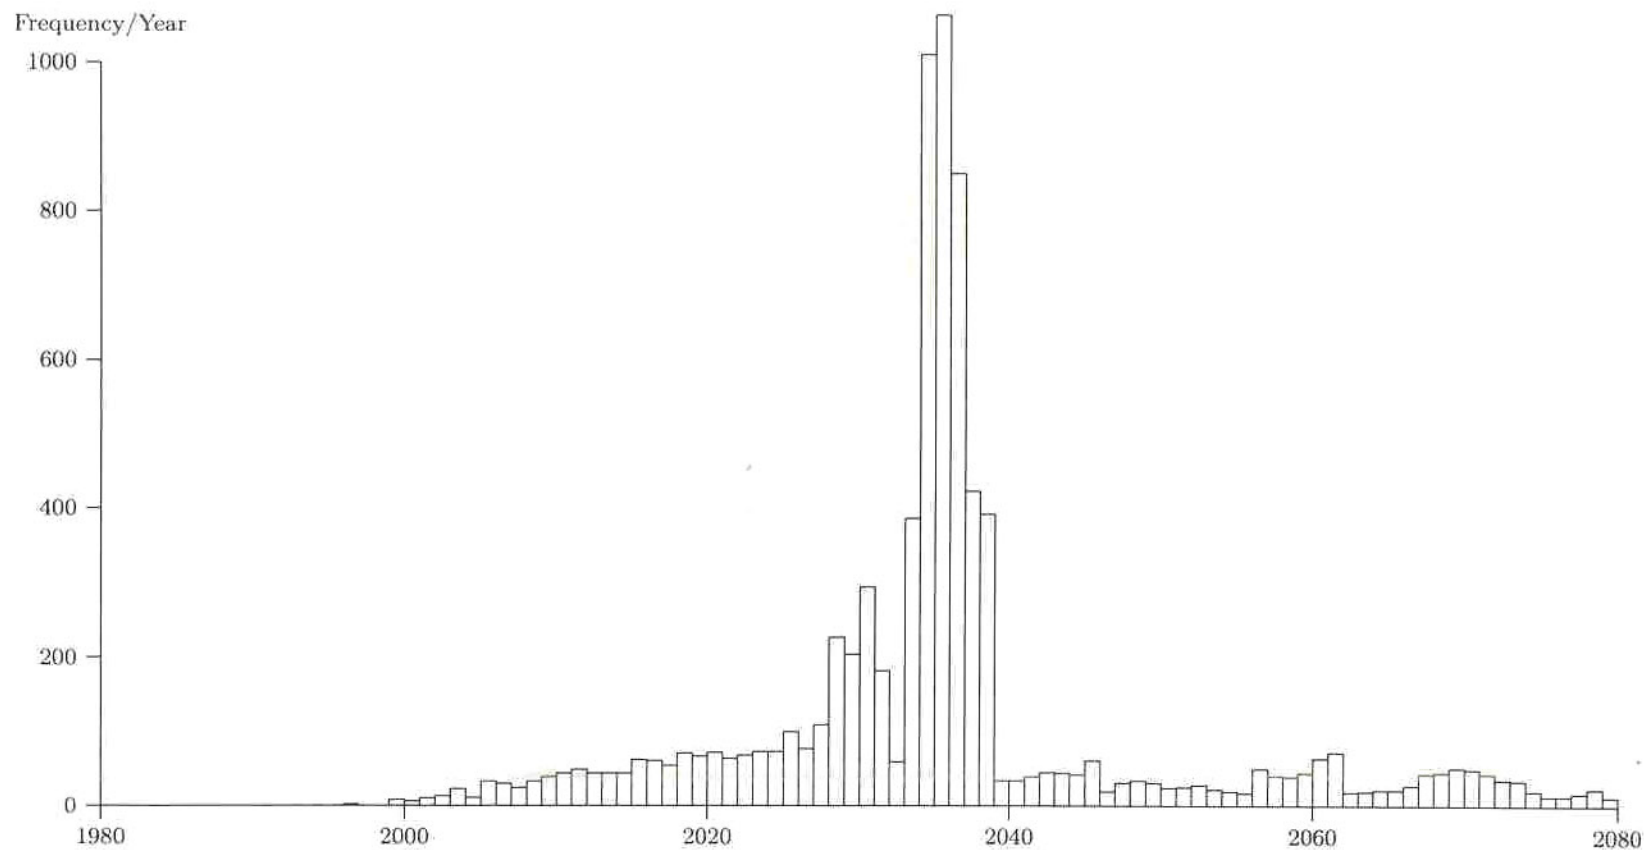
An example of output from FailDate is shown in Figure 3. The horizontal axis is the year and the vertical axis is the expected frequency per year of

ruptures or leaks. The frequency rises gradually, peaks, and then falls to a lower value again. In this example all of the features expected to fail before 2040 are growing, and those expected to fail after 2040 have shown little evidence of growing.

Figure 3: Histogram of Failure and Leak Dates

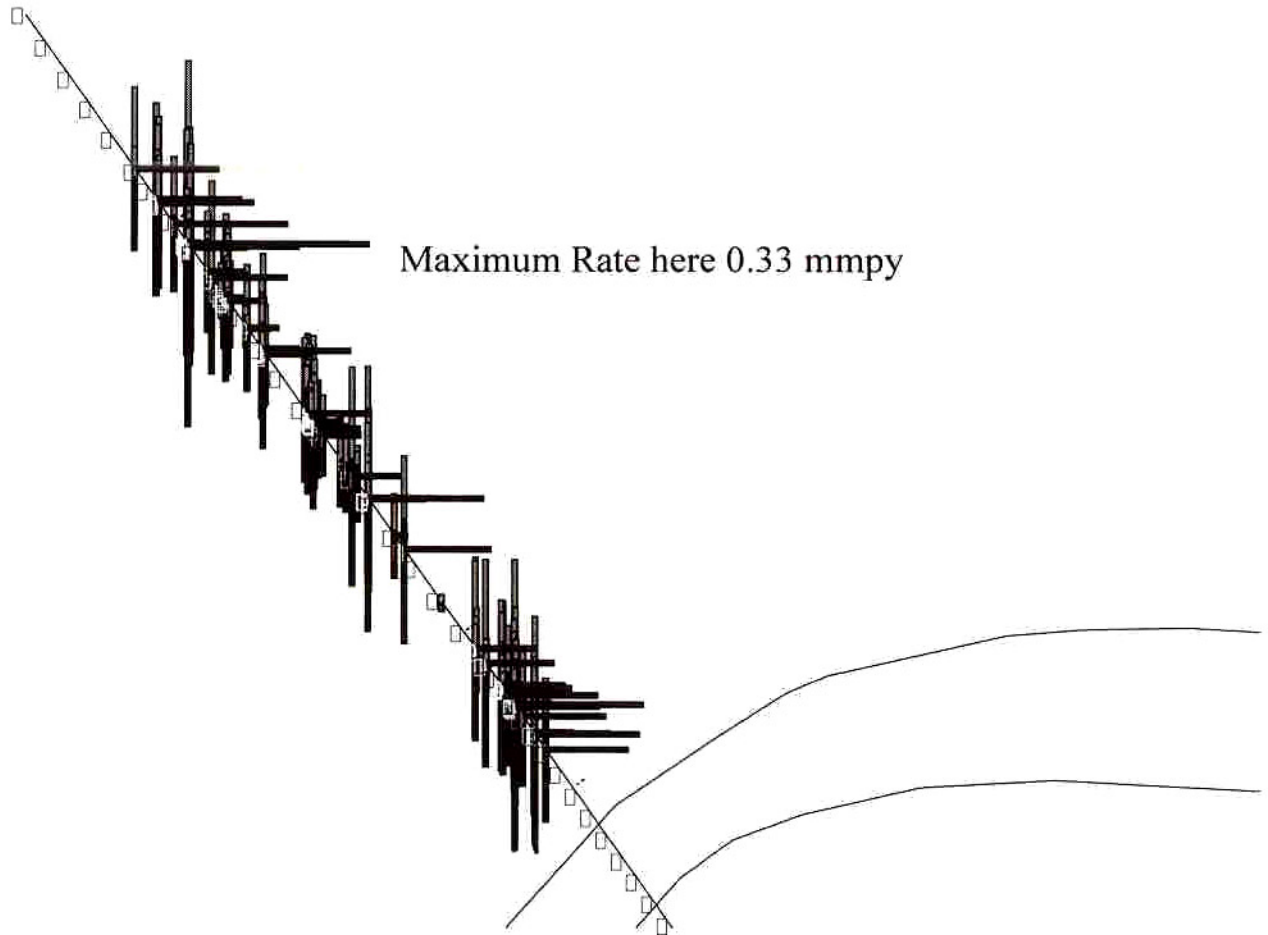
By displaying the corrosion rate and occurrence data on a geographical information system platform, more explanation as to the “why” of corrosion can be obtained. The corrosion data has also been compared with a soils model and NOVAProbe data to enable as complete and detailed an understanding as possible of the corrosion and its relationship to the local environment. See Wilmott et. al (1995) for a description of the NOVAProbe. For example, active corrosion on slopes and pipeline CP system problems not previously identified were discovered. Figure 4 shows an example of corrosion on a hillside. Soil creep on the hill has damaged the coating and resulted in the formation of a corrosion scenario.

The downward vertical lines are the expected penetration at some time in the future and the upward vertical lines are the penetration at the time of the last inspection. The horizontal lines are the penetration rate. In this example the maximum penetration rate on the slope is 0.33 mm/year.

Figure 4: Illustration of Growth on a Slope by a River
