# Rotating While Packed off May Cause Unexpected Heat-Induced Drill Pipe Tensile Failures

Samit Gokhale, SPE, Nicholas Reynolds, SPE, Sean Ellis, SPE  
T H Hill Associates, Inc.

## Abstract

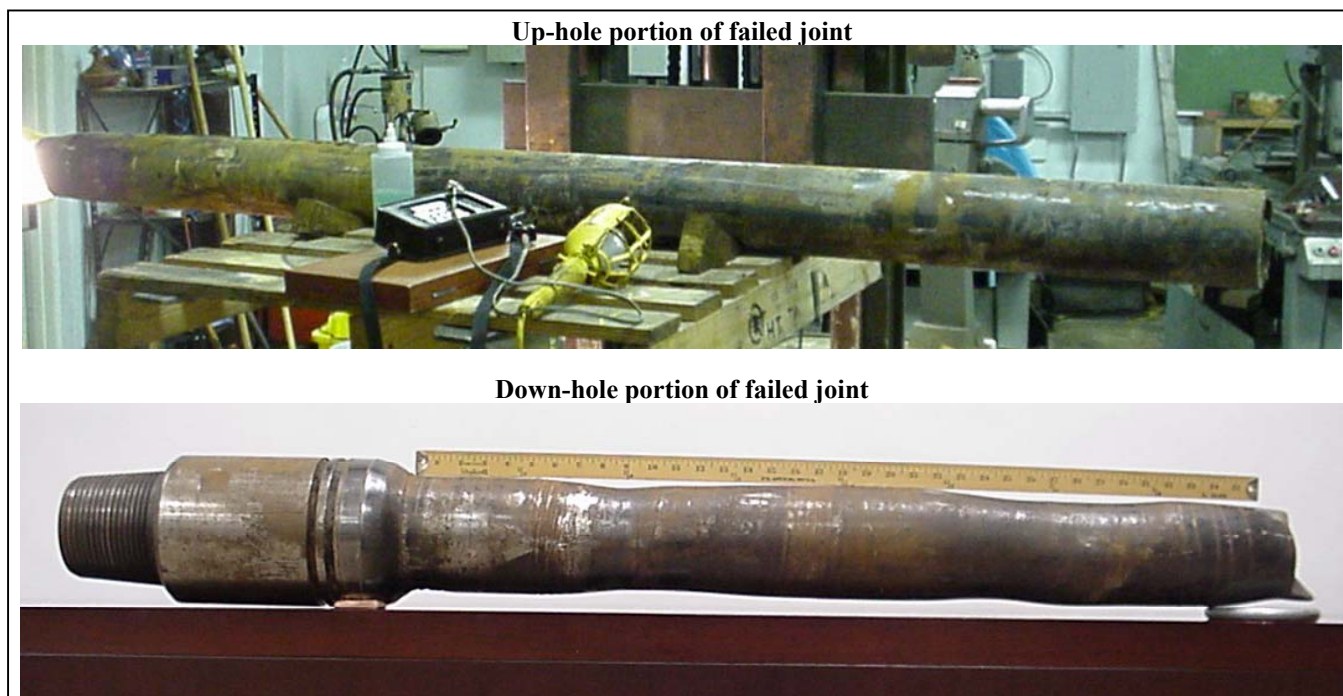
**Visual Examination:** The overall appearance and fracture morphology of joints C1 and C2 were strikingly similar. Both failures were located in drill pipe tube body, close to the pin connection tool joint. Joint C1 had parted 3'11" from the pin connection shoulder, while joint C2 had parted 6'5" from the pin connection shoulder. The fractured joints are presented in Figures 1 and 2.

Figure 1 – As received condition of the failed 5" 19.50# G-105 drill pipe C1

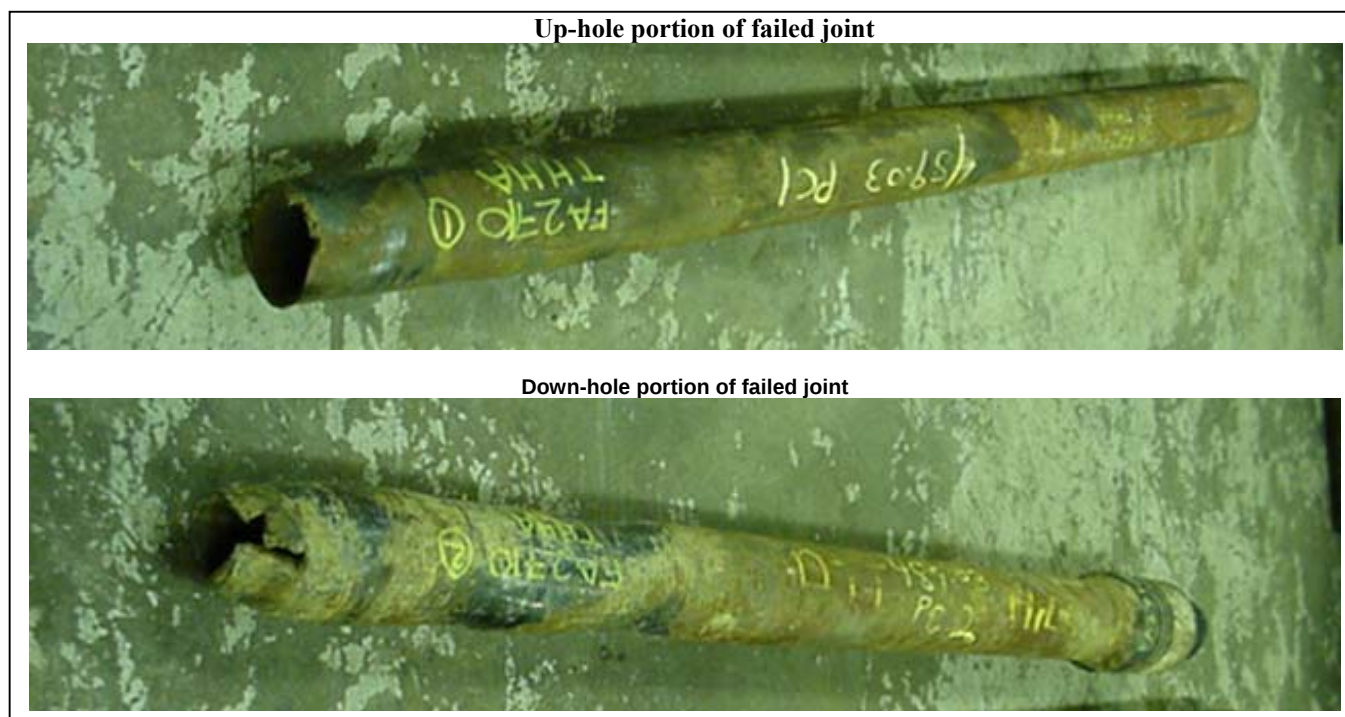
Figure 2 – As received condition of the failed 5" 19.50# S-135 drill pipe C2

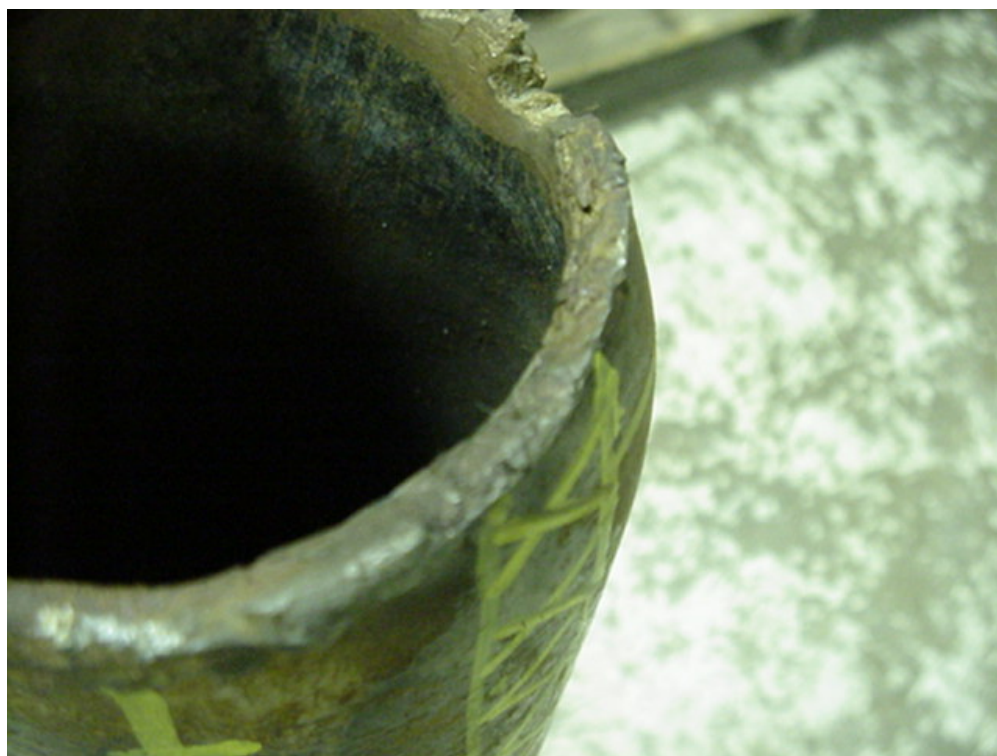
The fracture surfaces displayed evidence of a ductile separation under tensile loading. As shown in Figure 3, the fractures propagated along a 45 degree plane relative to the axis of the pipe. The fracture regions also exhibited significant necking and extensive plastic deformation. However, the necking was different from that observed on classic ductile overload failures. Joints *C1* and *C2* presented multiple closely spaced necked areas near the fractured ends. Figure 4 presents the necking and the plastic deformation. Overall, the fracture morphology was indicative of a ductile tensile overload.

Figure 3 – 45 degree fracture surface of joint C2

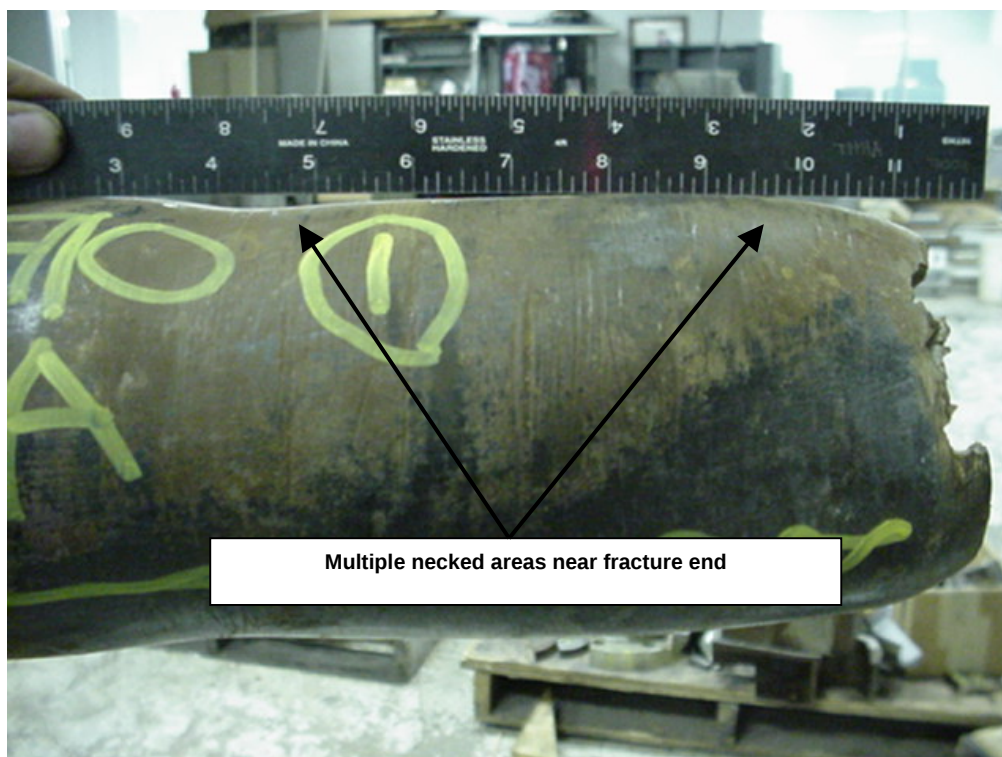
Figure 4 – Necking and plastic deformation observed near the fractured end of joint C2

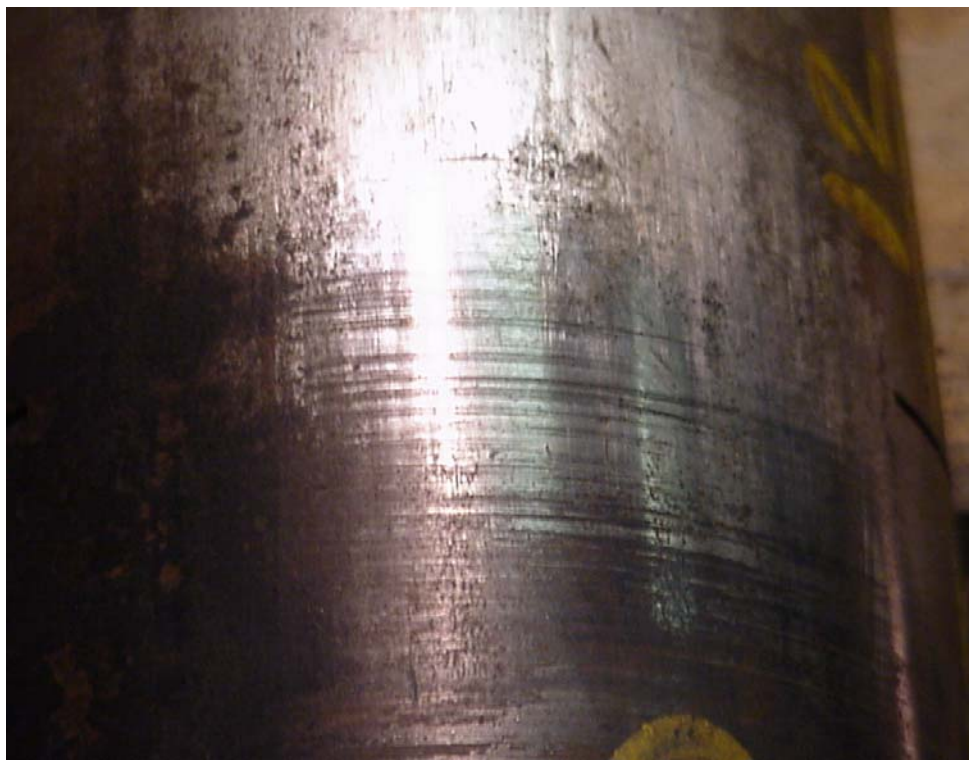
As shown in Figure 5, the outer surface of the joints near the fractured ends appeared "smooth" and "polished." Formation cuts and abrasion marks were also visible. It is likely that this damage resulted from rotation of the drill pipe against the formation.

Figure 5 – Formation cuts and polished outer surface on the tube body of joint C1

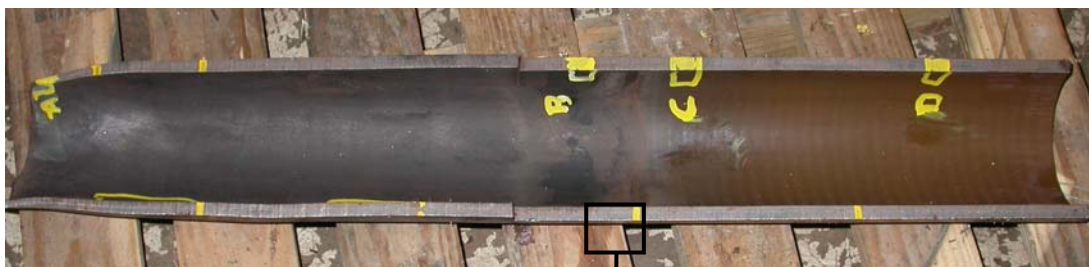
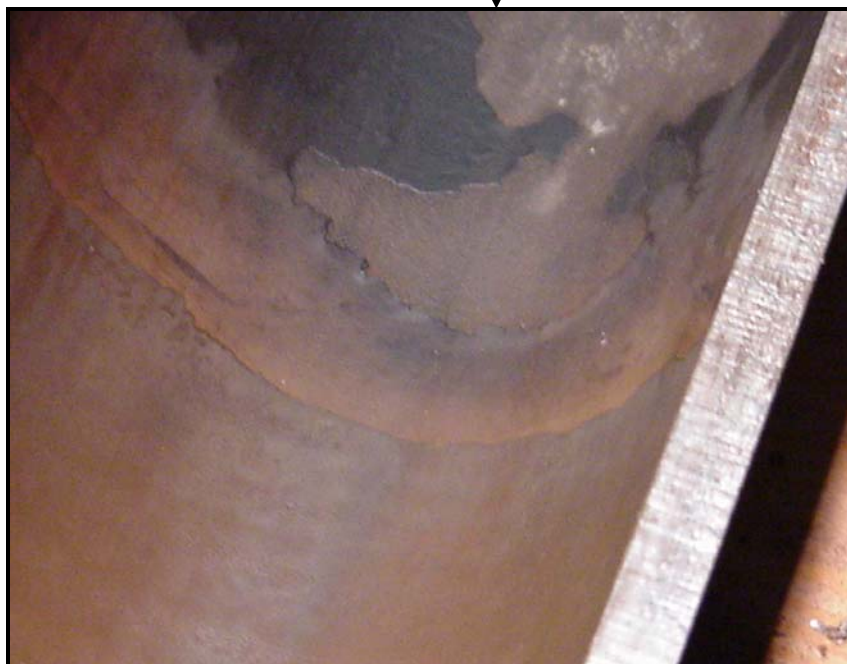
To evaluate the internal surface, the fractured joints were saw-cut longitudinally and split open. Figure 6 presents the condition of joint *C1*'s internal coating. The internal plastic coating was damaged close to the fractured end. The color and texture of the internal plastic coating also changed towards the fractured end. The damage appeared to have been caused by exposure to unusually high operating temperatures.

Figure 6 – Damage to internal plastic coating of joint C1 from exposure to high temperatures

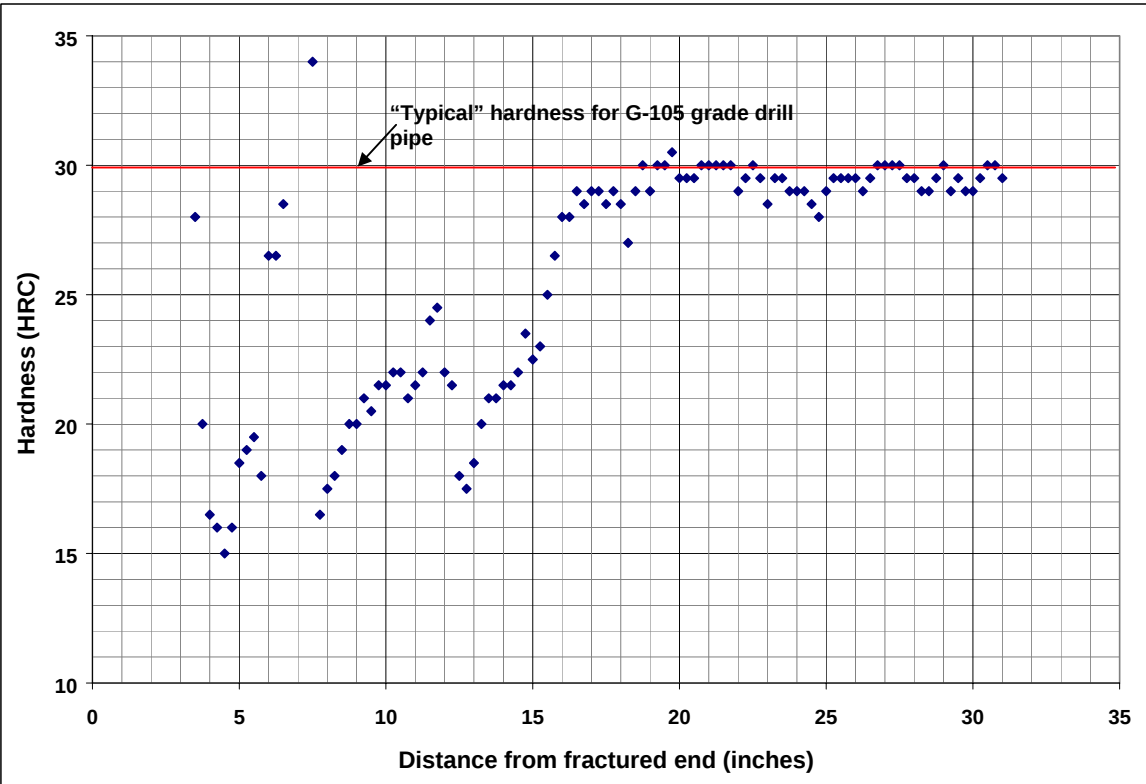
For joint C1 (G-105 drill pipe, typical Rockwell "C" hardness = 30 HRC), the average hardness reading outside the heat affected area was about 30 HRC. This hardness correlates to a tensile strength of about 136,000 psi. However, a drop in hardness to values as low as 15 HRC, which correlates to a tensile strength of about 100,000 psi, was observed near the fracture.

Figure 7 – Hardness (HRC) readings along the length of longitudinal section removed from joint C1

In cases of ductile overload failures, the hardness in the necked region is greater than the inherent material hardness due to strain hardening. However, in the case of the failed drill pipe joints *C1* and *C2*, the hardness in the heat affected area was significantly lower than the inherent material hardness. This reduction in hardness was indicative of localized heating near the fractured end to at least the tempering temperature.

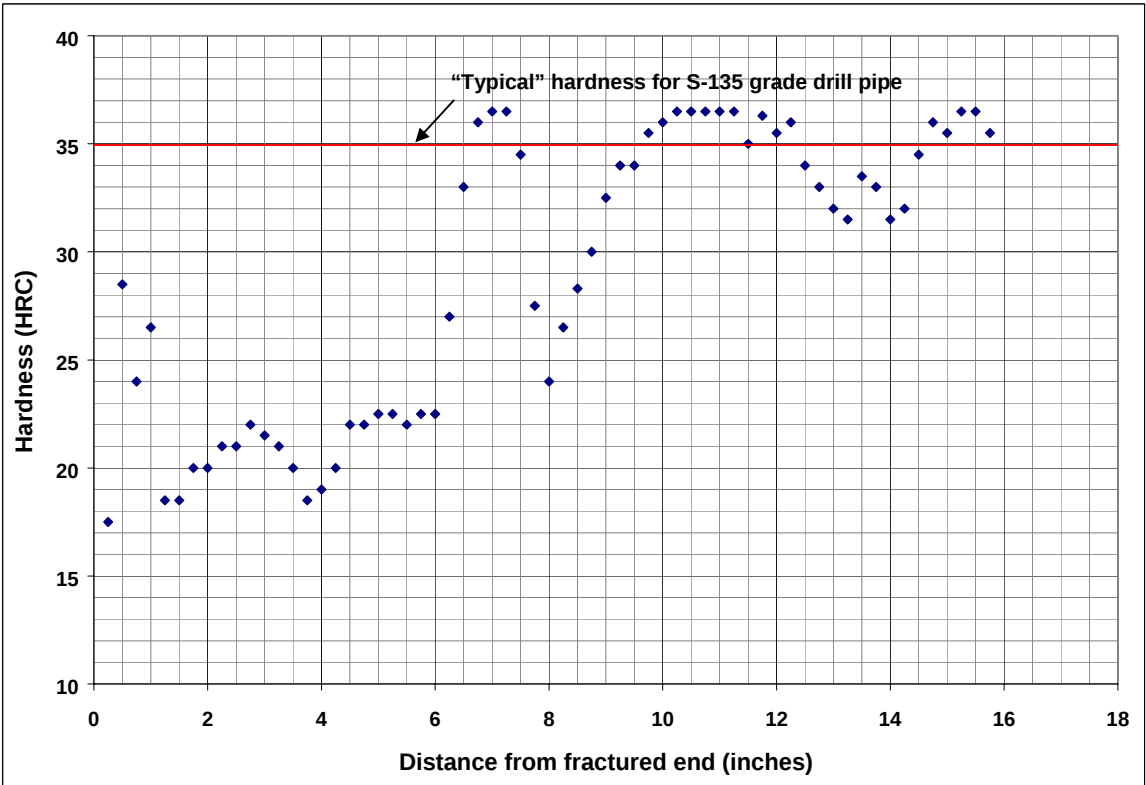
Similar to joint C1, a drop in hardness close to the fracture was observed on joint C2 (S-135 drill pipe, typical Rockwell "C" hardness = 35 HRC). The hardness values reduced from an average close to 35 HRC, which correlates to a tensile strength of about 157,000 psi, to values as low as 17.5 HRC near the fracture, which correlates to a tensile strength of about 104,000 psi.

Figure 8 – Hardness (HRC) readings along the length of longitudinal section removed from joint C2

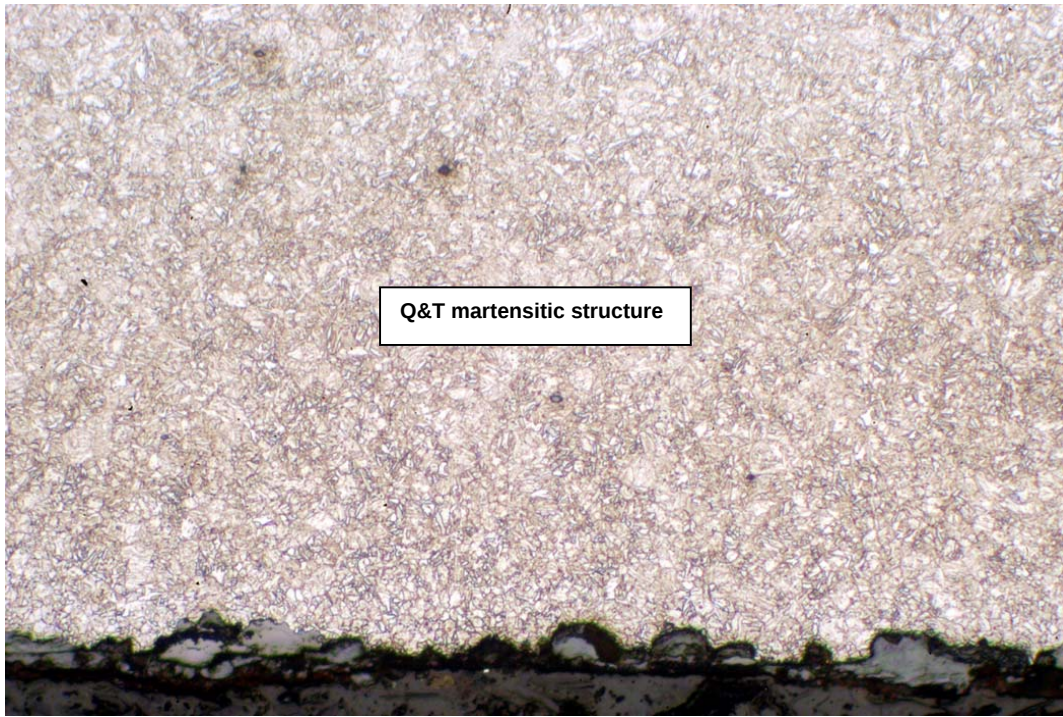
Specimens were removed from both inside and outside of the heat affected area of joint C2. Material from outside the heat affected area presented a tempered martensitic structure, which is characteristic of quenched and tempered (Q&T) steel, as required for S-135 grade drill pipe. This was the inherent drill pipe material structure. Material inside the heat affected area presented a mixed ferritic and pearlitic structure. Figures 11 and 12 present the two microstructures. Transformation of the grain structure in the heat affected area indicated that localized heating resulted in temperatures above 1,500°F (austenitic transformation temperature for joint C2 material, as shown in Figure 10).

Figure 11 – Inherent microstructure of joint C2 (200X)

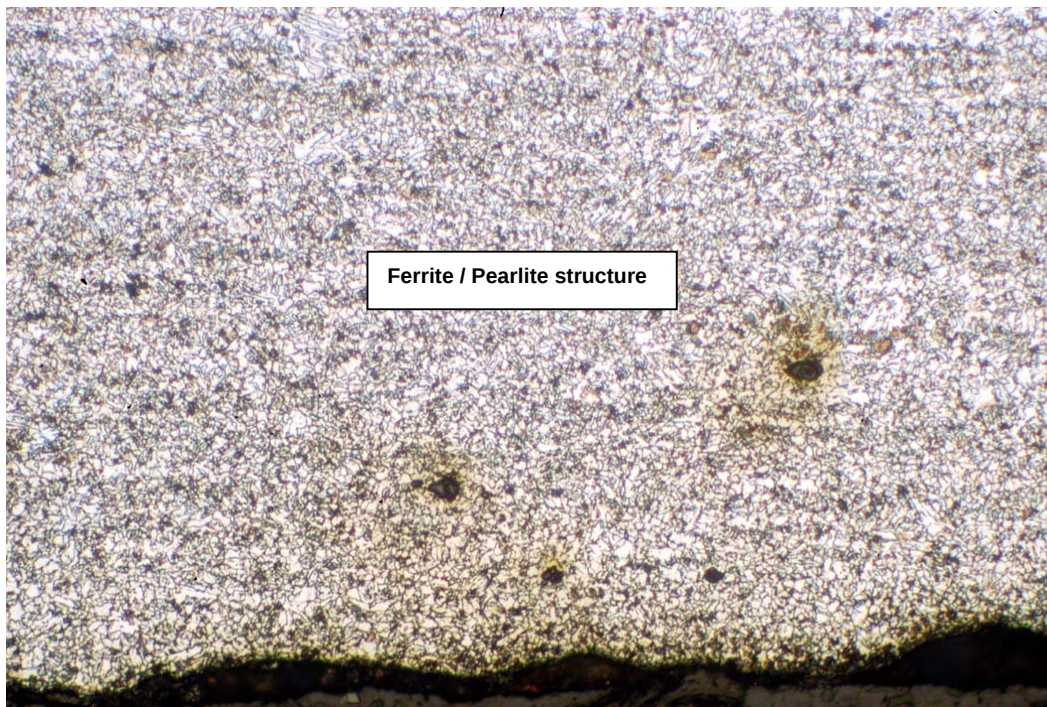
Figure 12 – Microstructure near fractured end of joint C2 (200X)

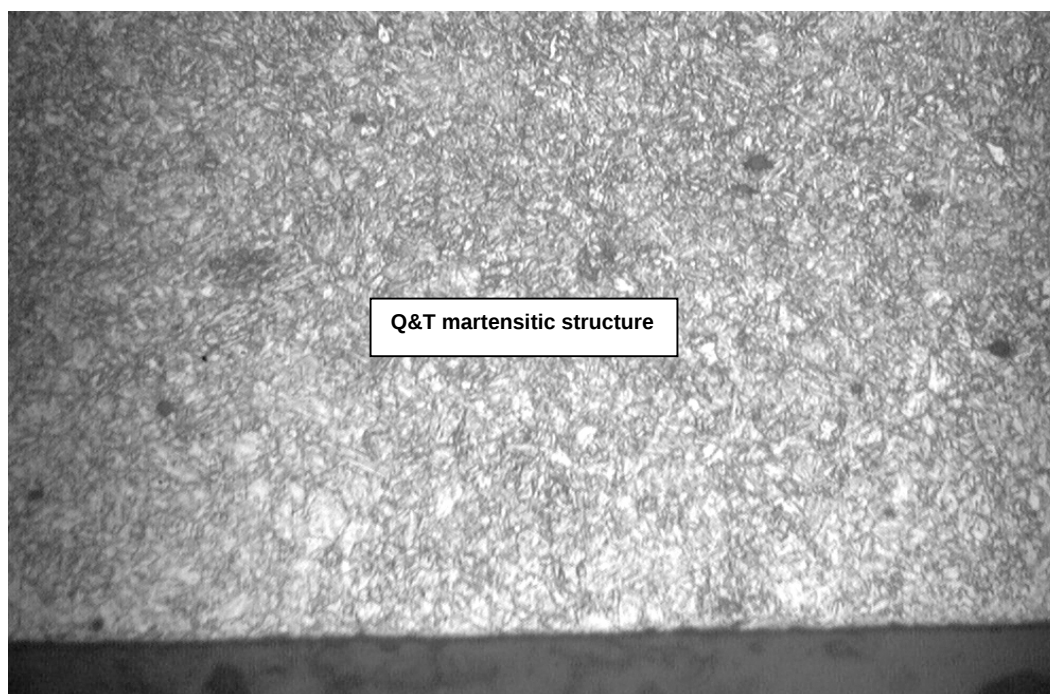
Specimens for microstructural examination were also removed from both inside and outside of the heat affected area of joint C1. However, unlike the change in structure observed on joint C2, both specimens removed from joint C1 presented a tempered martensitic structure. This is shown in Figures 13 and 14. Presence of a similar structure meant that the temperatures reached in the heat affected area of joint C1 did not exceed the austenitic transformation temperature ( $\sim 1,500^{\circ}\text{F}$ ). Instead the temperatures reached were closer to the typical tempering temperature for G-105 grade drill pipe material ( $\sim 1,000^{\circ}\text{F}$ ).

Figure 13 – Inherent microstructure of joint C1 (200X)

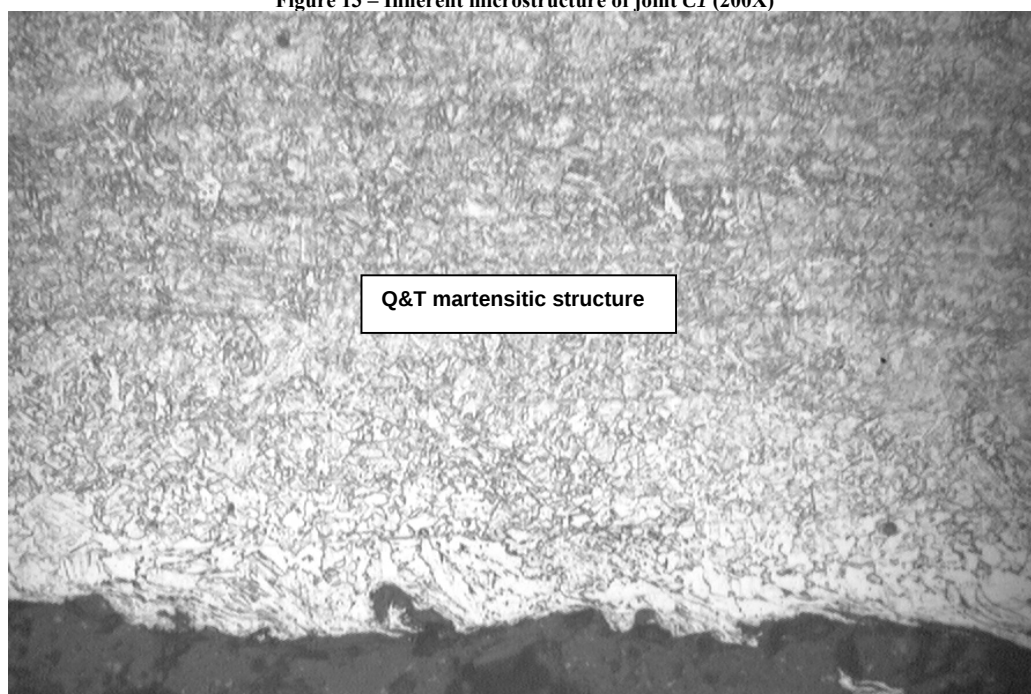
Figure 14 – Microstructure near fractured end of joint C1 (200X)
