IBP1062\_06

## USE OF PRESSURE ACTIVATED SEALANT FOR REPAIR OF DEEPWATER DRILLING RISER LEAKS, A CASE STUDY

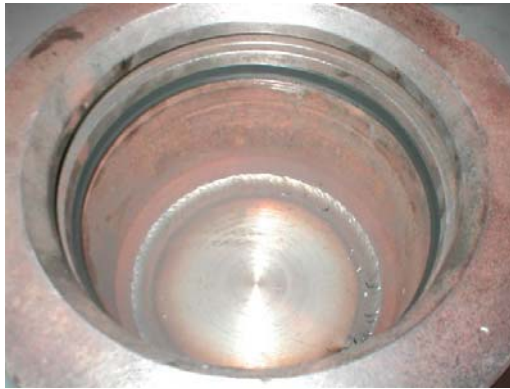
Figure 1. Box Connection

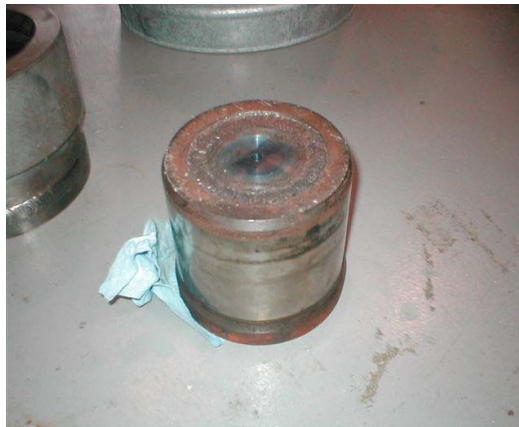
Figure 2. Pin Connection

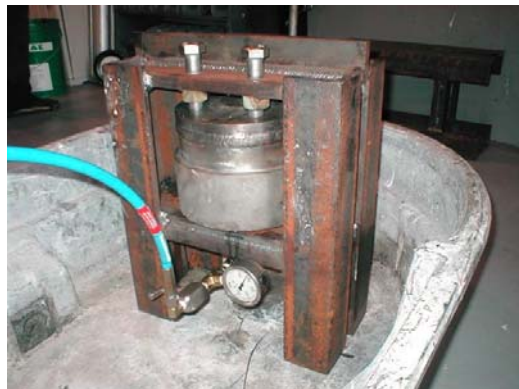
Transocean provided to Seal-Tite a typical pin-and-box connection from a 4" I.D. riser choke line. The open ends of the tubes were seal-welded and injection/pressure monitoring ports were added. Due to the significant separation forces that high pressure testing would create, a containment frame was constructed to house the connections and allow safe observation of the testing activities. Below in Figures 1, 2 and 3 are photographs of the box connection, pin connection and the testing frame.

Figure 3. Testing Frame

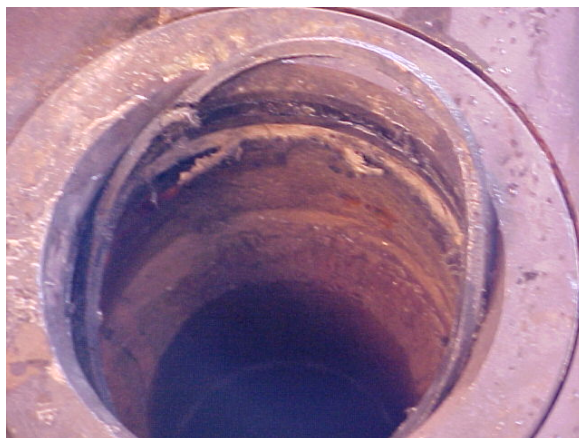
The well was then taken to TD over the next 30 days. Normally the BOP/Riser equipment would be tested every 14 days. However to provide maximum confidence in the sealant process, the choke line was successfully tested to 7500 psi every three days. Once the well had been suspended, the riser was pulled to the leaking connection and the damaged seals removed for inspection. Below in Figures 4, 5, 6 and 7 are photos of the riser stack and seal subs as they were removed. It can be seen that one of the polypack seals was completely separated. The second polypack seal had significant damage to the seal areas.

Figure 5. Damaged Choke Line Seals in Riser

The Marianas was equipped with a typical cementing unit including two 10 bbl paddle-type blending tanks. To ensure accurate system volumes a dye pill was displaced to the leak site while volumes were carefully monitored. A 2.5 bbl sealant pill was prepared in one 10 bbl tank while the second tank was utilized to prepare 3 bbls of gel pad. The gel pad was only used to help protect the sealant pill – one barrel was pumped ahead of the sealant and 2 bbls were pumped behind. The sealant was displaced to the leaking connection with seawater by circulating down the choke line and taking returns on the kill line. Once in position the BOP crossover valve was closed and sealant was squeezed into the leaking seals. Over the next 12 hours the sealant injection pressure was steadily increased until an 8000 psi seal was achieved. This pressure was held for 8 hours to allow the sealant to cure, during which no significant pressure bleedoff was observed. The sealant was then flushed from the system and the choke line tested to 7500 psi, allowing normal drilling operations to resume.

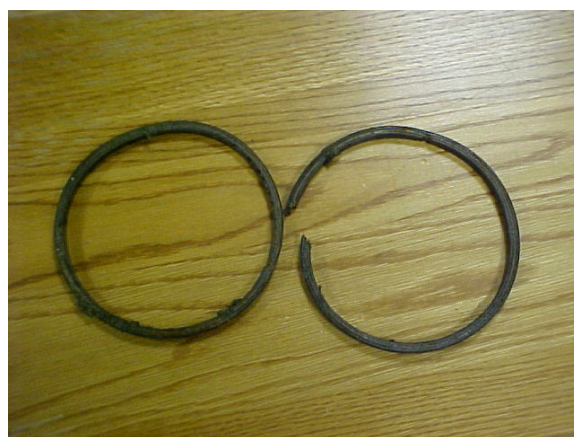
Figure 6. Damaged/Split Choke Line Seals

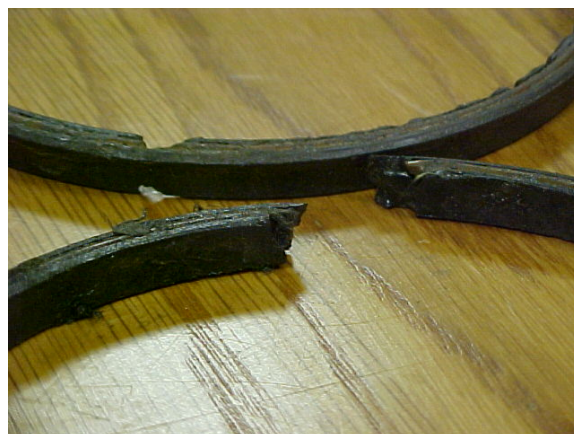
During this repair the riser was subjected to severe loop currents as high as 2.6 knots. These currents caused significant oscillation in the riser, and clearly had an impact on the repair as a small amount of sealant could be seen coming from the leak point with each oscillation of the riser. It is logical to assume that this movement also contributes to abnormal wear of the polypack seals.

Figure 7. Close-up of Damaged Seals
