# **The Influence of Interference Currents from Lightning-Rod Cables of Grid Steel Power Lines on the Corrosion Process of Tower Foundations**

**ELETROSUL – Empresa Transmissora de Energia Elétrica do Sul do Brasil S/A**

**UFSC – Universidade Federal de Santa Catarina**

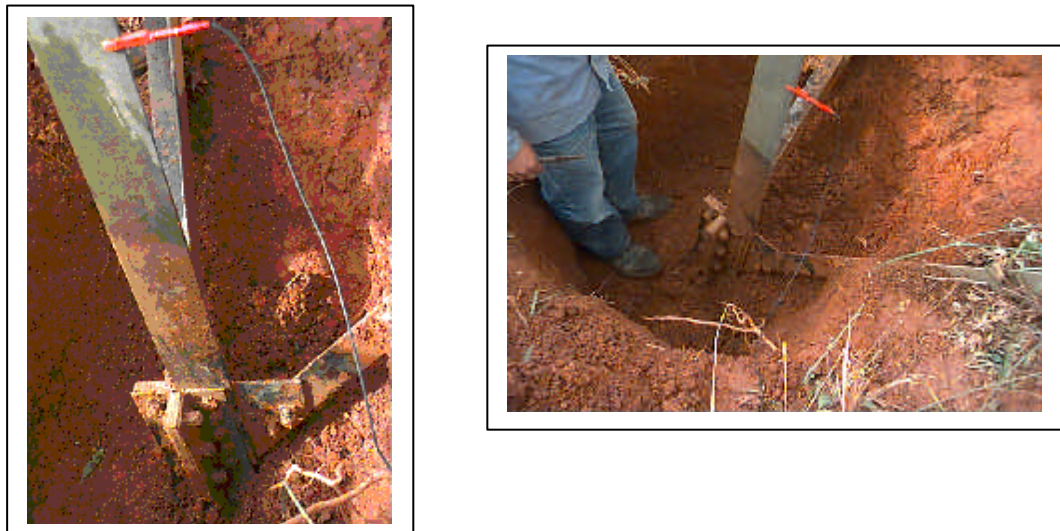
Fig.7 –Image of anodically polarized foundation

Plots having a positive slope ( $a = \tan \varphi$ ) were associated with anodic towers. The corresponding foundations were visually inspected in an attempt to assess the situation of the corrosion process. As it can be seen from Fig.7, the foundations showed evidence of extensive corrosion. The influence of the stray current flowing in those foundations was verified measuring the voltage at the base of anodic towers in advanced stage of corrosive degradation (Fig.7) (7).

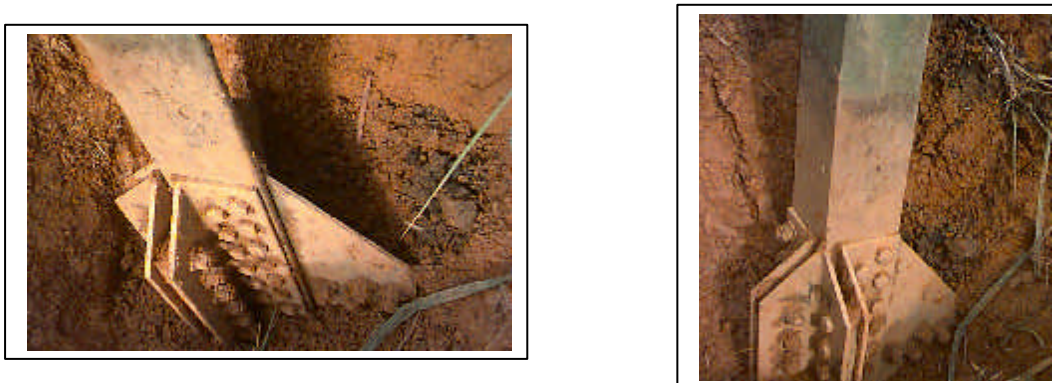
Fig.8 – Image of a cathodically polarized foundation

Conversely, plots with negative slope ( $-a = \tan \varphi$ ) suggested a cathodic process taking place at the foundations. Such towers were also visually inspected, but no signs of corrosion could be detected. Fig. 8 shows an example of a well preserved structure corresponding to a cathodic tower.
