# Rotating While Packed off May Cause Unexpected Heat-Induced Drill Pipe Tensile Failures

Samit Gokhale, SPE, Nicholas Reynolds, SPE, Sean Ellis, SPE  
T H Hill Associates, Inc.

## Abstract

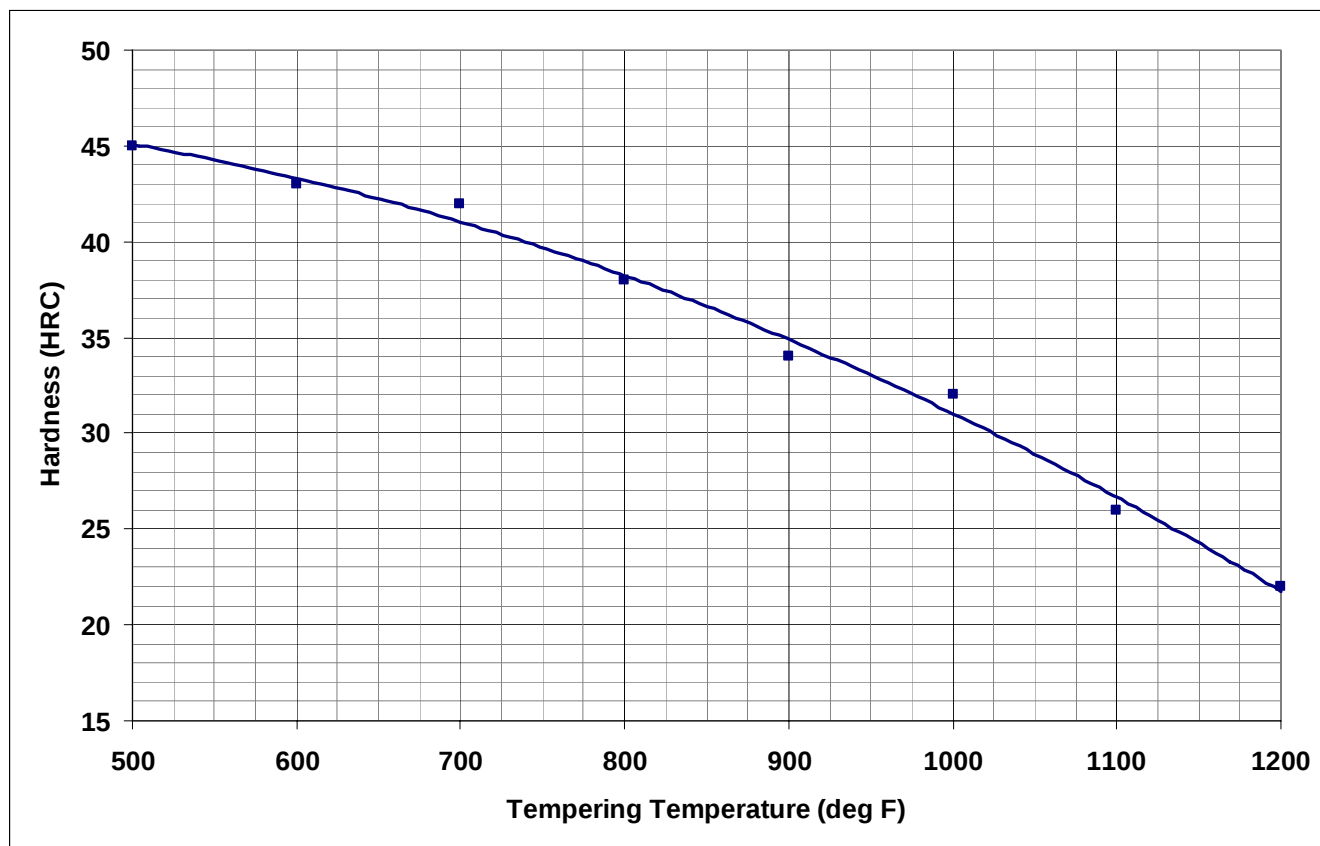
“Tempering of steel is a process in which previously hardened steel is heated to a temperature below the transformation range and cooled at a suitable rate, primarily to increase ductility and toughness.<sup>3</sup>” Tempering usually results in a decrease in hardness, tensile strength and yield strength, but an increase in ductility and toughness. Figure 9 shows the effect of tempering temperature on the hardness of 4130 alloy steel (this is the same material from which joints *C1* and *C2* were made).

Figure 9 – Hardness of 4130 Alloy Steel After Tempering<sup>4</sup>

Increased temperatures reduces the strength of steel. Yield strength decreases to zero when the material reaches the melting point. As joints *C1* & *C2* were locally heated near their fracture locations to temperatures greater than or equal to their tempering temperatures, their material hardness (and thus strength) decreased. The load capacities of the drill pipe tubes were reduced resulting in the ductile tensile overload failures. The hardness values and corresponding tensile strengths reported for joints *C1* and *C2* were measured after the joints had been cooled. The actual hardness and corresponding tensile strength values at the time of the failures would have been much lower. However, because there is no way of knowing what temperatures the drill pipe joints reached when rotated while packed off, the tensile strength at the time of failure is unknown.

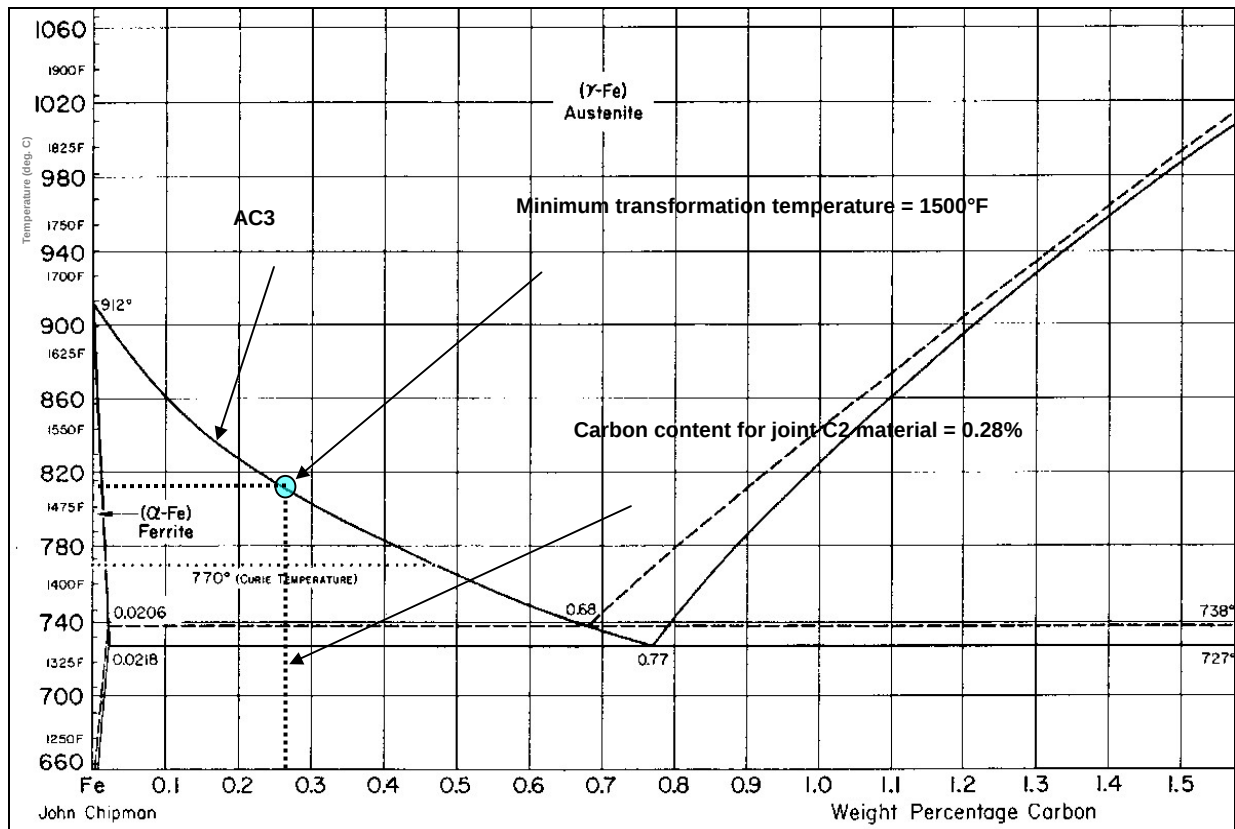
microstructure in the heat affected area and compare it with the microstructure outside the heat affected area. A change in the microstructure (from the inherent structure) in the heat affected area would mean that the temperatures reached were greater than the austenitic transformation temperature. This minimum phase transformation temperature is represented by line “AC3” on the Carbon-Iron phase diagram shown in Figure 10.

Specimens were removed from both inside and outside of the heat affected area of joint C2. Material from outside the heat affected area presented a tempered martensitic structure, which is characteristic of quenched and tempered (Q&T) steel, as required for S-135 grade drill pipe. This was the inherent drill pipe material structure. Material inside the heat affected area presented a mixed ferritic and pearlitic structure. Figures 11 and 12 present the two microstructures. Transformation of the grain structure in the heat affected area indicated that localized heating resulted in temperatures above 1,500°F (austenitic transformation temperature for joint C2 material, as shown in Figure 10).

Figure 10 – Carbon-Iron phase diagram<sup>5</sup>
